Technical Service Bulletin

Topic	Unusual Suspension Behaviour whilst static Continental GT/GTC/Flying Spur 18-24MY
Market area	Australia E04 Bentley rest Asia and Australia (6E04),China 723 Volkswagen (Anhui) Automotive CO (6723),China 796 VW Import Comp. Ltd (Vico), Beijing (6796),Germany E02 Bentley rest Europe (6E02),Japan E03 Bentley Japan (6E03),Korea, (South) E08 Bentley South Korea (6E08),Russian Federation 935 Volkswagen Group RUS (6935),United Arab Emirates E06 Bentley Middle East and Africa (6E06),United Kingdom E01 Bentley UK (6E01),United States E05 Bentley USA and rest America (6E05)
Brand	Bentley
Transaction No.	2064555/2
Level	EH
Status	Released for publishing
Release date	May 13, 2025

Continental GT/GTC and Flying Spur

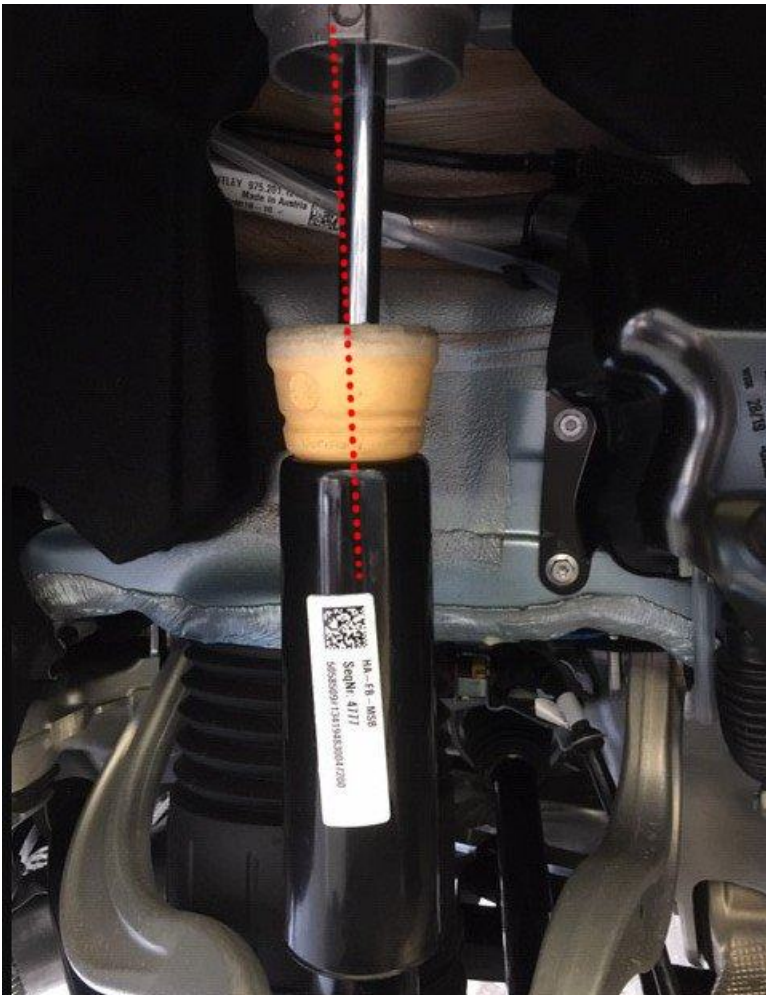
Figure 1

- 1) Carry out an inspection the left and right hand rear shock absorbers, checking for damage,leaks and/or misalignment as shown in Figures 1,2 and 3

2) In the event that one or both of the rear shock absorbers are as shown/described - Replace the affected shock absorber. Refer to ElsaPro, Repair Group 42 'Shock absorber – remove + install'

- Both shock absorbers should be replaced if there is an old version of the damper on the vehicle and only if the new version is available for ordering in ETKA. This is to avoid different versions of shock absorber fitted to the same vehicle.
- Both of the shock absorbers should be replaced on the vehicle if it has completed over 10000+km of mileage.
- If fitted, inform the customer that the new shock absorber is going to settle down and perform optimally after 1000km of vehicle running.
