Field campaign

Topic	Software Update BiL 5.3.1 v1 to v2 Flying Spur 25MY (SC25/11)
Market area	Bentley: worldwide (2WBE),China 796 VW Import Comp. Ltd (Vico), Beijing (6796)
Brand	Bentley
Transaction No.	2077583/6
Campaign number	ED42
Note	
Type	
US code

25MY Flying Spur

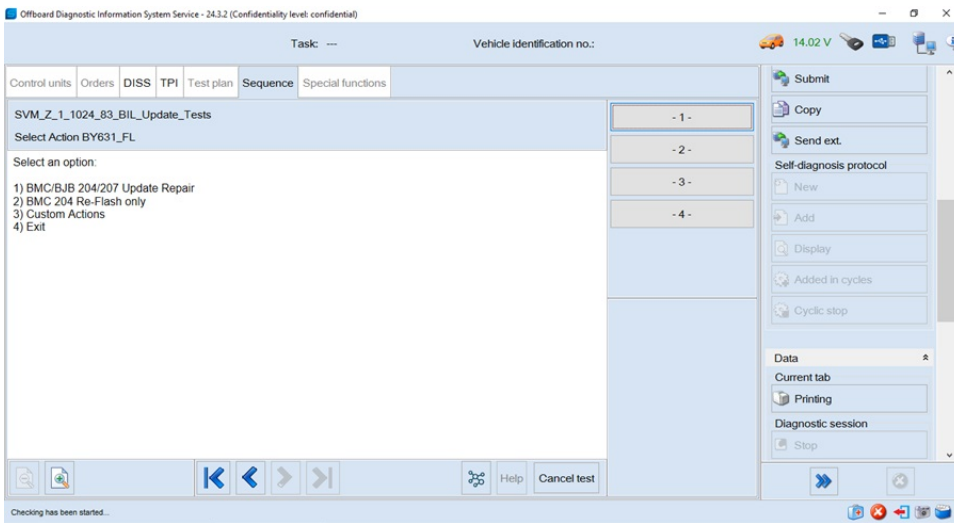
- When the tester attempts to flash '008C - Battery regulation control module' you may receive a message informing you that the pre-conditions have not been met. Select 'done/continue'.
- On the following screen (shown below) select option 2 to attempt to flash the ECU – this should allow the '008C - Battery regulation control module' to flash successfully.

- If the flash fails, perform the below actions.

1. Exit the test.

2. Allow the car to sleep for 5 minutes.

- Turn off the ignition.
- Remove all equipment from the car (Diagnostic tester/dongle, battery charger, keys).
- Close all doors, windows, bonnet and boot lid.
- Lock the vehicle to perform a CAN-BUS sleep (wait 5 minutes).

3. Clear DTCs from '008C - Battery regulation control module'.

3a. To do this, right click on control unit 008C, click Guided Functions and then click 'Clear Fault Memory'.

4. Return to 'Special functions' and run the test plan 'SVM – Pre 372BIL5201 Hotfix Routines'.

5. Within this test plan, select option 2 and run until completion.

6. Once the test has been completed, right click on control unit 008C and select guided functions. Then, read ECU Identification and ensure that the 06D0 (Battery Junction Box) appears as a subsystem within the read identification test plan.

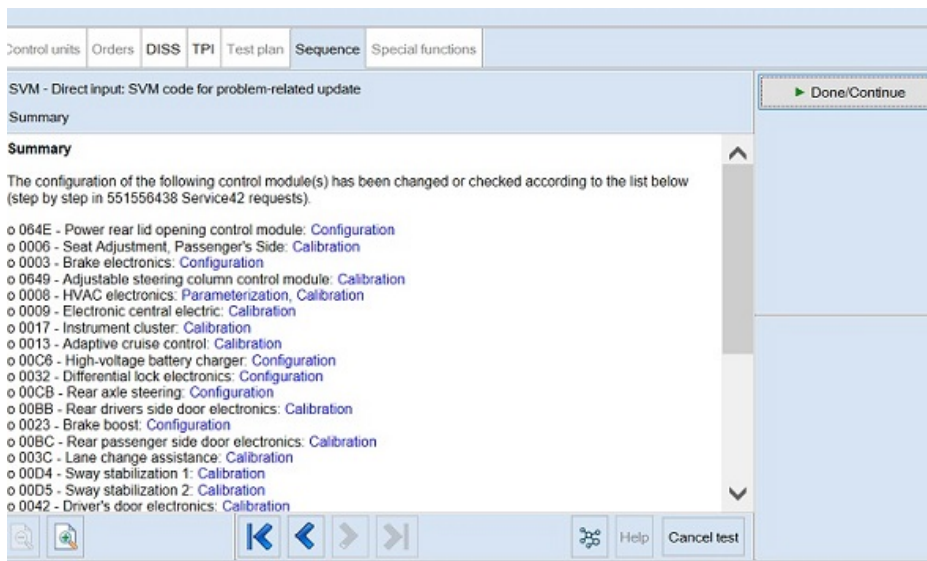
Fig 3

8. Follow the on-screen instructions to completion.
9. If you are presented with this screen (Fig 3) at the end of the update, the update was successful. Please continue to step 11.

10. If you encounter any errors during the update, please raise a FULL TECHNICAL DISS query.
 - a. Customer Statement: “ED42 Support”
 - b. Workshop Findings: Give a summary of the error encountered and ensure that the latest Guided Fault Finding log is submitted online.
11. After successful completion of the update, perform the following.
 - a. Turn off the ignition.
 - b. Remove all equipment from the car (Diagnostic tester/dongle, battery charger, keys).
 - c. Close all doors, windows, bonnet and boot lid.
 - d. Lock the vehicle to perform a CAN-BUS sleep (wait 15 minutes).
12. After 15 minutes, unlock and open the driver’s door. Turn on the ignition, re-connect the battery charger and diagnostic dongle.
13. Re-run guided fault finding and clear DTCs. If any faults are present, refer to TPI 2075920. If any other faults are present, please raise a full

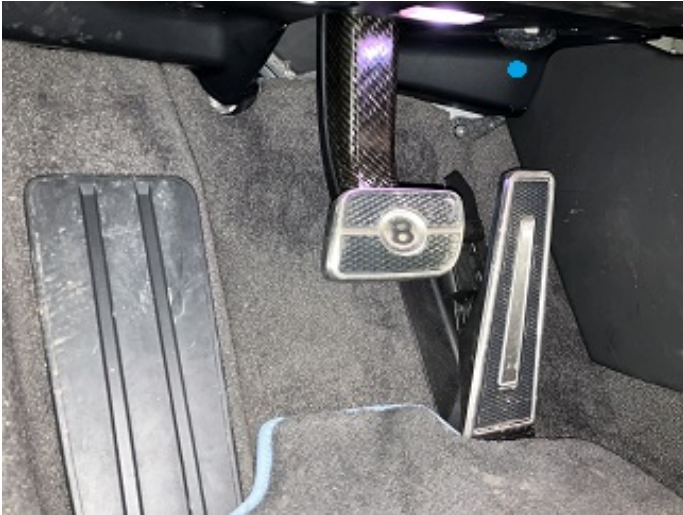
You must also add a blue paint mark as per the picture below.
