**SERVICE CAMPAIGN 75-08 Revel Alternator Output Adjustment
AFFECTED MODELS: 2022 - 2024 Revel & 2025 Revel Sport**

Revel Alternator Output Adjustment

Field Service Campaign

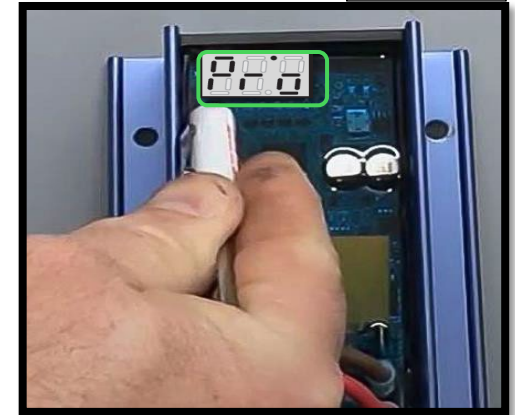
- A. With the regulator turned on, TOUCH & HOLD the magnet end of the supplied screwdriver to the RED dot on the front of the regulator.
- B. The regulator will display '**Pro**'. Remove the magnet from the red dot when '**Pro**' is displayed. (See Figure 1 Outlined in Green)

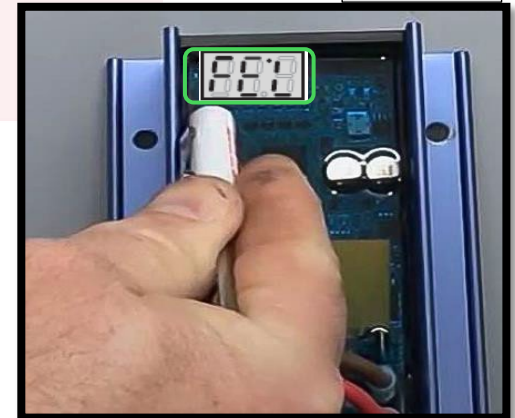
- When the regulator displays **FEL**, TOUCH and HOLD the magnet to the RED dot. This will put the regulator in belt load programming mode. (See Figure 2 Outlined in Green)

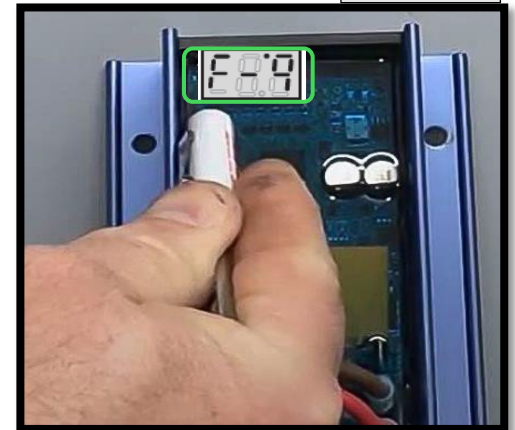
- The Regulator will now cycle from **F-0** to **F-9**. When display indicated **F-9**, RELEASE the magnet. This will set the maximum field to **F-9**. (See Figure 3 Outlined in Green)

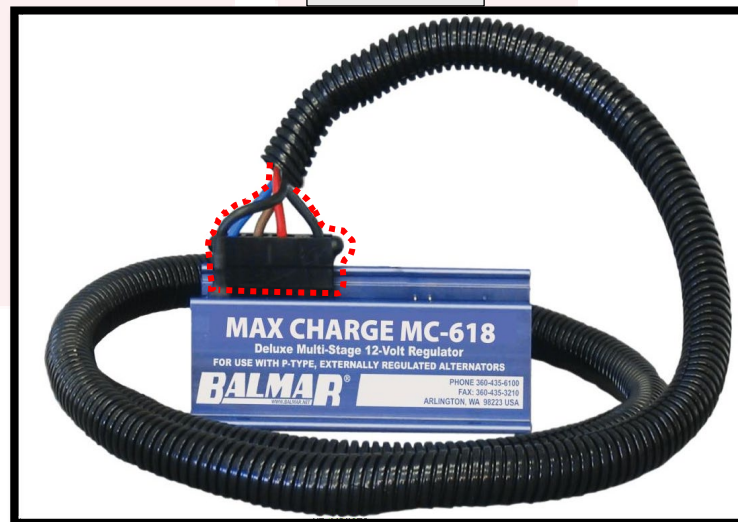
1. Reprogramming of the MC618 regulator is now complete. This reprogramming should provide increased reliability and longevity from the Balmar Secondary Alternator.
2. If at any point during operation a Whining noise is heard from the secondary alternator, disconnect the black 4-pin connector from the MC – 618 regulator. (See Figure 4 - Highlighted in Red dashes). If you need assistance, please Contact Winnebago Tech Support by calling 1-866-653-4329 or by email: techservice@wgo.net
3. Provide the last page of this Work Instruction Set to the Owner of the Unit (Customer Notice).

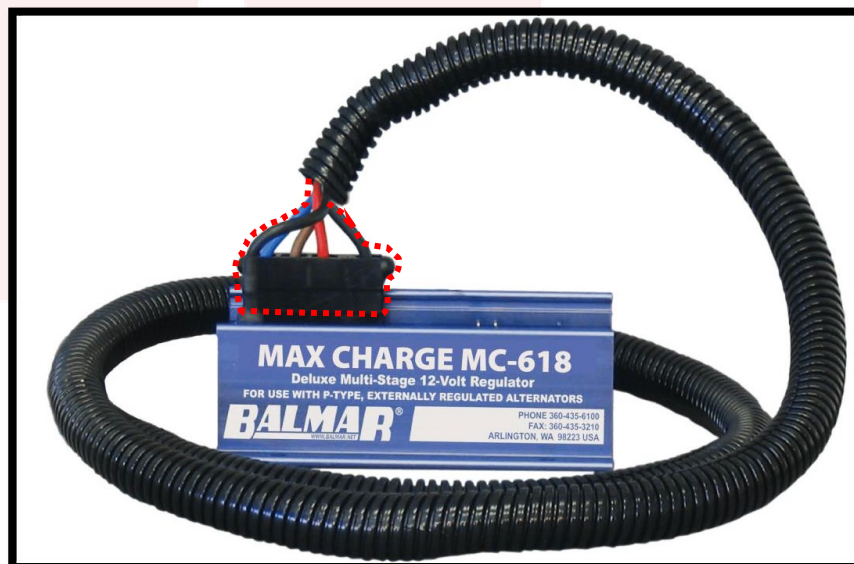
Should you notice any unusual charging system behaviour (e.g.: unexpected battery drain, or a whining noise) please disconnect the 4-pin connector from the regulator (See Figure Below) and contact Winnebago Customer Care by calling [1-800-537-1885](tel:1-800-537-1885) or by email: customercare@wgo.net.
