May 21, 2025

Version 6

Warranty Extension: 2017–19 Multi Model 6AT Torque Converter – DTC P0741 StoredSupersedes 23-078, dated April 18, 2025, to update the information highlighted in **yellow**.**AFFECTED VEHICLES**

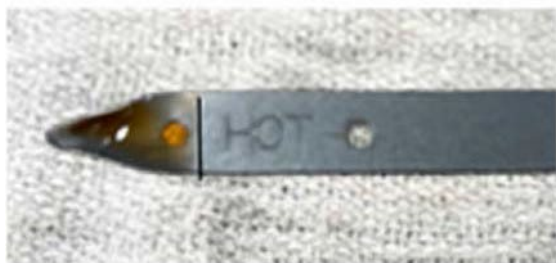
COLD CHECK

- Overfilled transmission level can cause an overheat condition.
 - Check the ATF level when the fluid temperature is greater than or equal to **80°C (176°F)**.
 - If the fluid level is checked at a cooler temperature, it will read low or on the bottom dot of the dipstick.
 - If the transmission fluid is filled to the top dot when cold, the transmission will be overfilled, increasing foaming, and contributing to the overheating problem.
2. Check ATF level.
