Field campaign

Topic	Software Update BJB and HV ECUs Continental GT/GTC/Flying Spur 25MY (SC25/10)
Market area	Bentley: worldwide (2WBE),China 796 VW Import Comp. Ltd (Vico), Beijing (6796)
Brand	Bentley
Transaction No.	2077696/5
Campaign number	ED40
Note	
Type	
US code

25MY Continental GT/GTC/Flying Spur

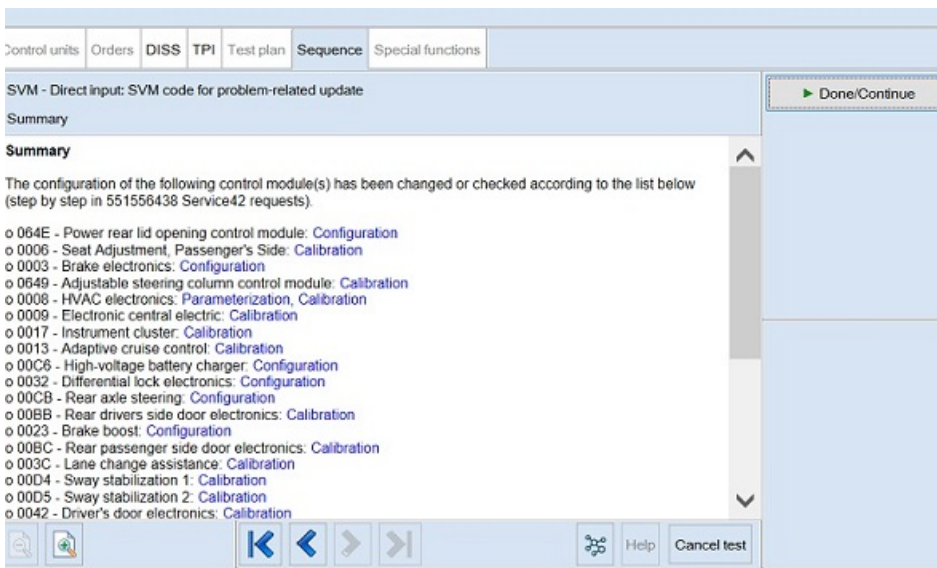
Fig 3

8. Follow the on-screen instructions to completion.
9. If you are presented with this screen (Fig 3) at the end of the update, the update was successful. Please continue to step 11.
