Technical Service Bulletin

Topic	E-Machine temperature fault DTC P0A2E00 Bentayga and Flying Spur (Hybrid) 20-23MY
Market area	Bentley: worldwide (2WBE),China 796 VW Import Comp. Ltd (Vico), Beijing (6796)
Brand	Bentley
Transaction No.	2077783/1
Level	EH
Status	Released for publishing
Release date	May 22, 2025

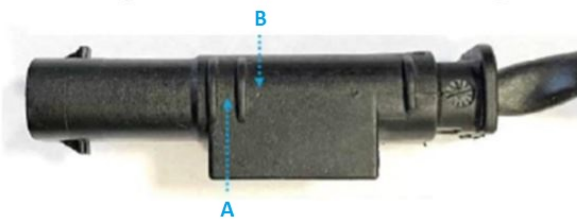
Figure 1

Use figure 1 to help identify old and new level parts. Pay particular attention to the markings shown.

Markings shown by **A** (*indentation between the rib*) = **New level parts**

Markings shown by **B** (*Indentation to the right of the rib*) = **Old level parts**

3. Install the new level electric drive temperature sensor.
