Technical Service Bulletin

Topic	Sporadic All-Wheel Drive Warning Continental GT/GTC and Flying Spur 25MY
Market area	Bentley: worldwide (2WBE), China 796 VW Import Comp. Ltd (Vico), Beijing (6796)
Brand	Bentley
Transaction No.	2077545/1
Level	EH
Status	Released for publishing
Release date	May 28, 2025

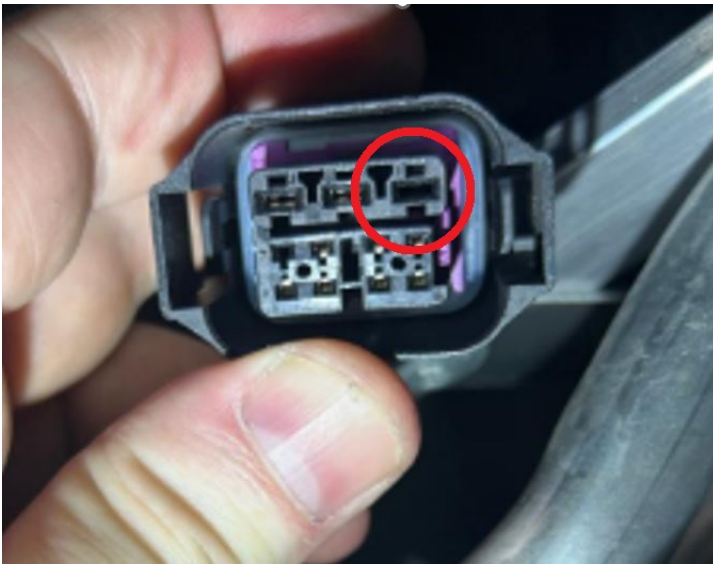
Figure 1

Potential issue with the T16-way connector at J647, causing intermittent faults in the differential lock system due to:

- Poor electrical contact
- Corroded or loose terminals
- Defective terminals.

1. Inspect the T16-way connector at J647 for any defective terminals.

2. Perform a detailed check of the terminals within the T16-way connector at J647.
3. If any terminals are found to be defective as per the example in figure 1.

- Replace all all the defective individual terminals (part number P00293586).

- If required replace the entire 16-way connector at the J647 unit (part number (P00427711)).
