Technical Service Bulletin

Topic	Creaking From the Rear of the Vehicle - Diagonal Strut Brace Bolt Loose
Market area	Bentley: worldwide (2WBE),China 796 VW Import Comp. Ltd (Vico), Beijing (6796)
Brand	Bentley
Transaction No.	2076757/1
Level	EH
Status	Released for publishing
Release date	May 12, 2025

25MY Continental GT & Flying Spur

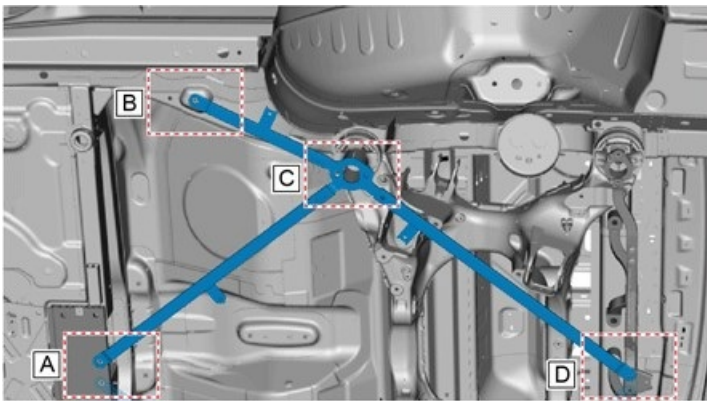
Figure 2

The source of the banging noise is the diagonal strut brace (Figure 1)

The bolts on either side, highlighted in box B (Figure 2) are coming loose and causing the noises from the diagonal strut brace.

1) Check the torque value of bolt “B”, highlighted in Figure 3, on BOTH sides of the vehicle. Refer to ElsaPro, Repair group 51 “Diagonal Strut Brace – To remove and fit”.

2) If the bolt is not within the specified torque this could be due to contamination. Remove the bolt and replace with the new bolt (see parts information).

Before replacing the bolt ensure the thread is cleaned to remove any wax.

NOTICE
Ensure the bolts are torque tightened to the specified torque.

New part number for bolt “B” – N.909.201.02
