Service Bulletin

Bulletin No.: 23-NA-115

Subject: Ticking, Tapping or Snapping Noise from Engine - 5.5L RPO LT6 Realign Camshaft Caps as Required

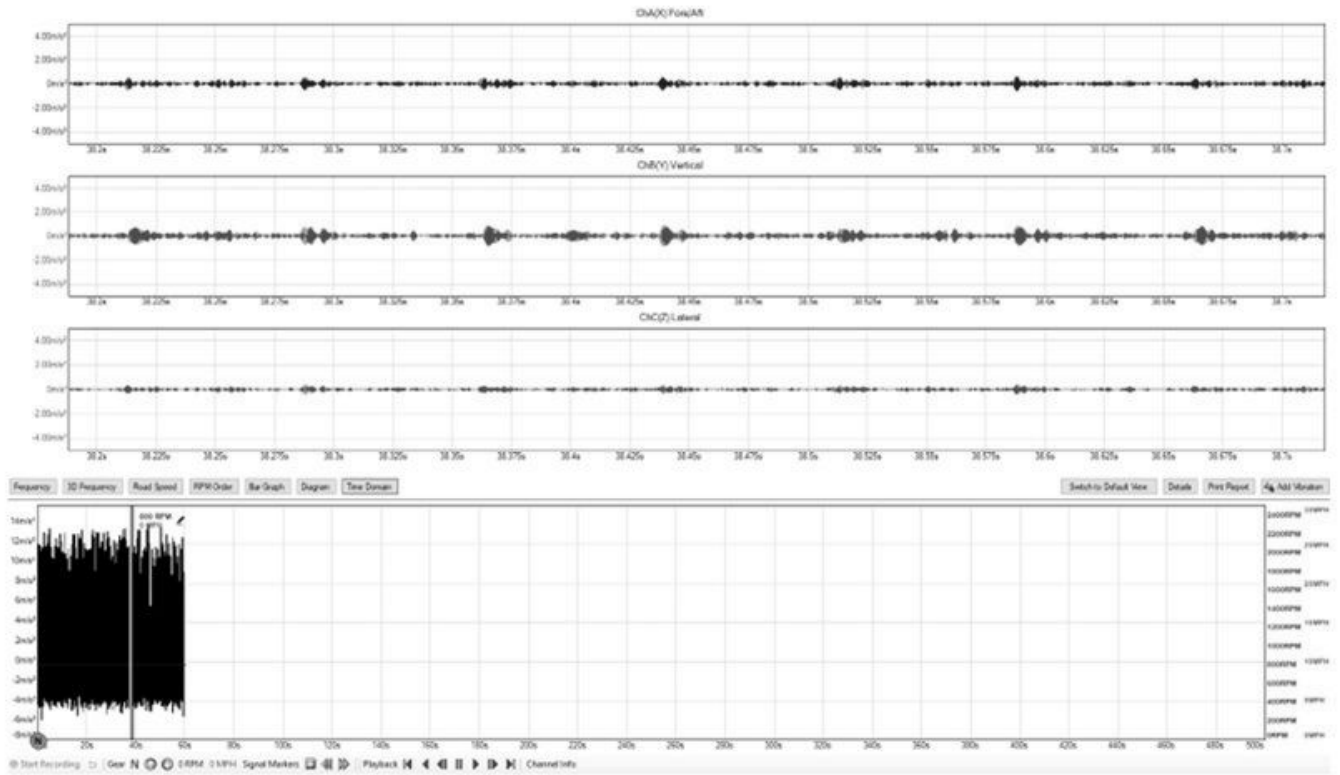
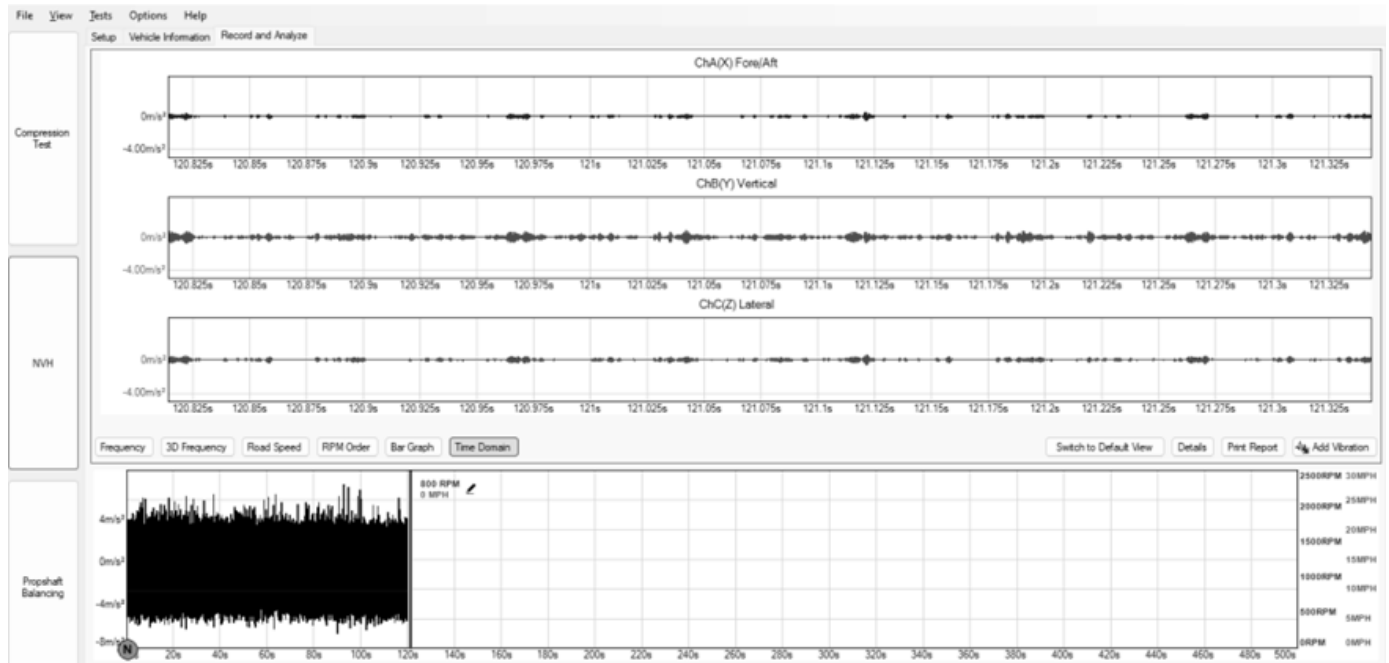
6375036

Examples of No Tick:
