Service Bulletin

Bulletin No.: 23-NA-198

Subject: HVAC Not Cooling Cabin During a Remote Start

Brand:	Model:	Model Year:		VIN:		Engine:	Transmission:
		from	to	from	to		
Chevrolet	Trax	2024	2025	—	—	—	—

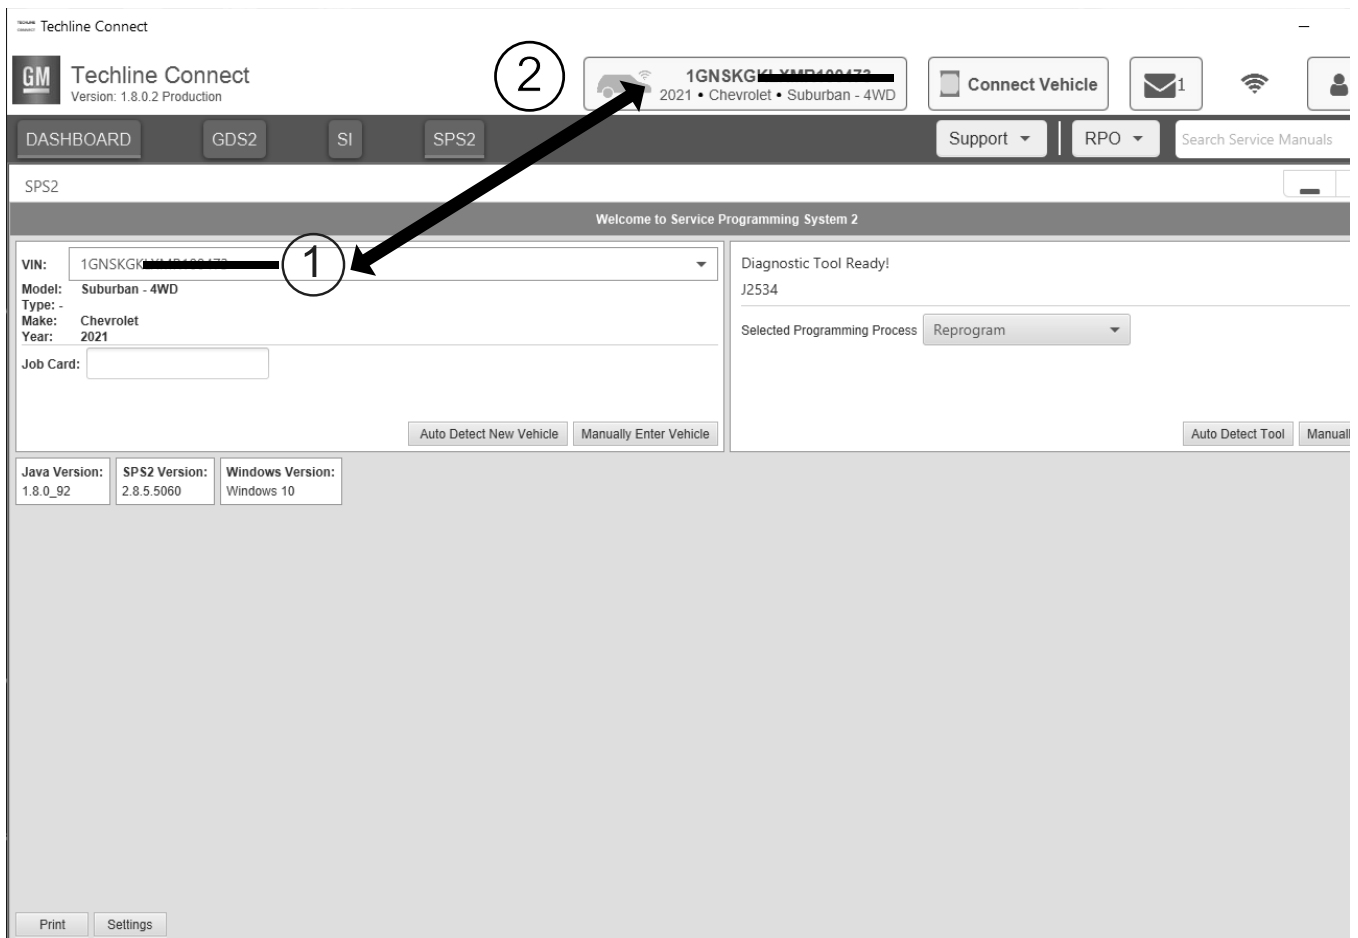
5743643

Caution: Be sure the VIN selected in the drop-down menu (1) is the same as the vehicle connected (2) before beginning programming.
