# Trailer Driving Assist Active Message Displayed Without a Trailer Connected

YEAR(S)	MODEL(S)	ADDITIONAL INFORMATION
2024	Tacoma, Tacoma HV

April 16, 2025 Rev1:

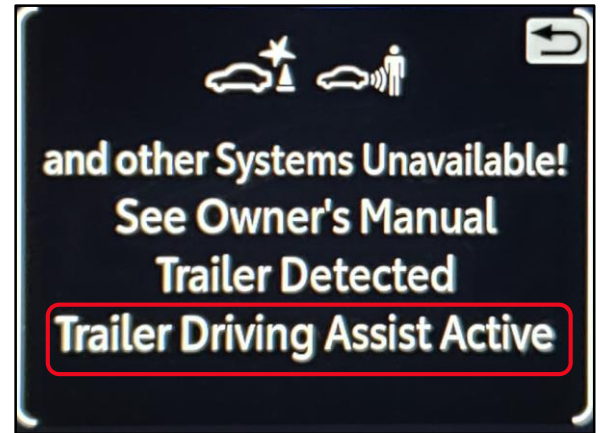
**Figure 1.**

Some 2024 Tacoma and Tacoma Hybrid vehicles equipped with a Blind Spot Monitor (BSM) may exhibit a condition where the Trailer Driving Assist Active message is displayed without a trailer connected. The BSM software has been updated. Follow the Repair Procedure in this bulletin to address this condition.

1. Confirm the condition exists.  
 Is the Trailer Driving Assist Active message displayed without a trailer connected, as shown in Figure 1?
  - **YES** — Continue to step 2.
  - **NO** — This bulletin does NOT apply. Continue diagnosis using the applicable Repair Manual.

- Flash reprogram the BSM sensors.

Follow the procedures outlined in [T-SB-0021-25](#), *GTS+ ECU Flash Reprogramming With Security Signature*, and flash reprogram BOTH BSM sensors with the NEW calibration file update.
