Service Bulletin

Bulletin No.: 24-NA-022

Subject: SUV Second-Row Bolt Torque Pattern

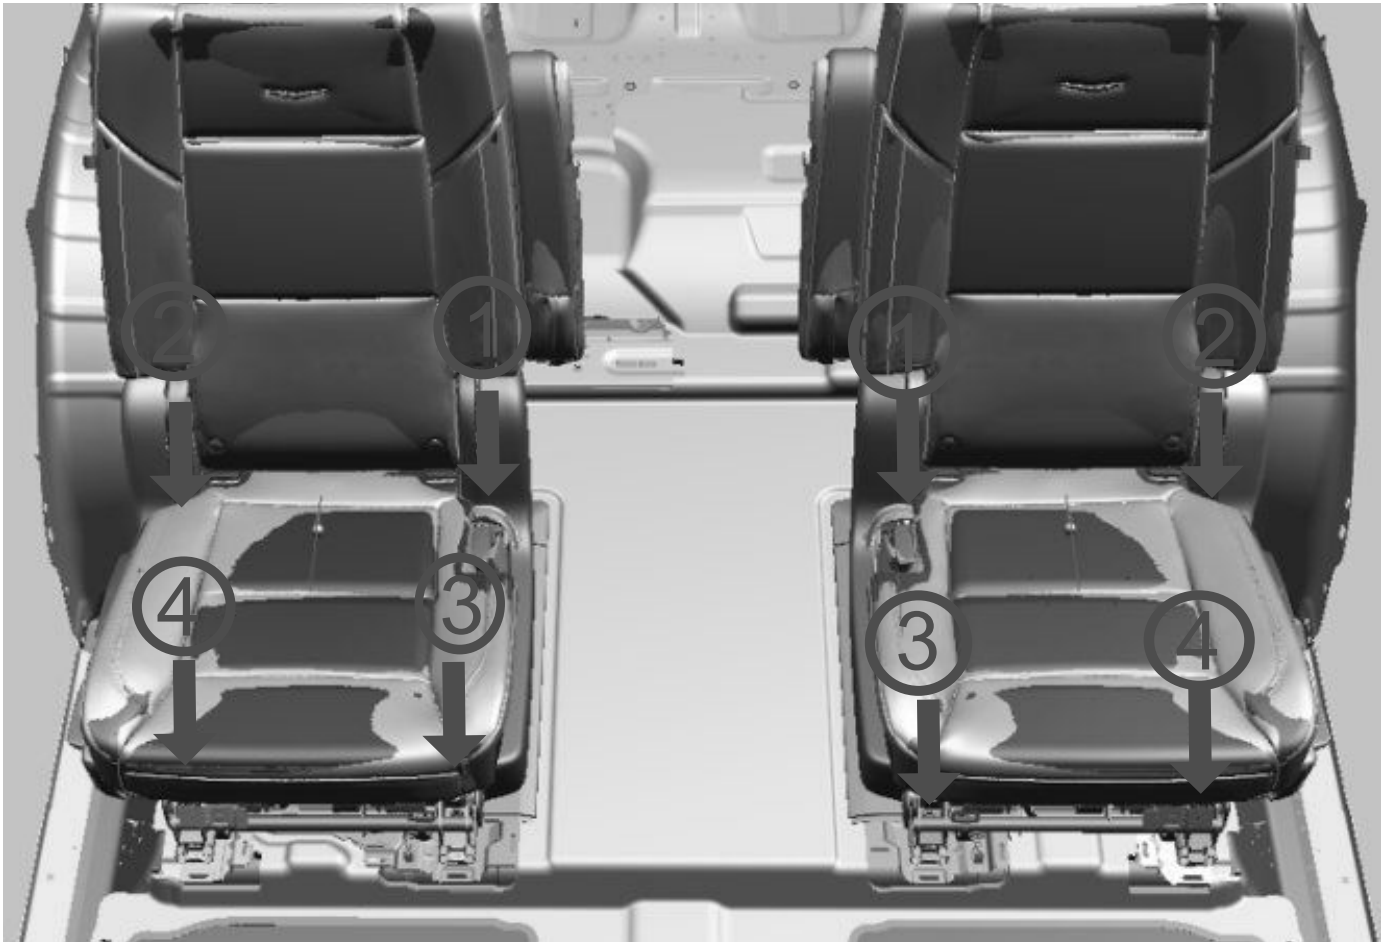
6535673

Captains Chairs

1. Refer to document *Rear Seat Removal and Installation* for instruction on how to reuse fasteners or install new ones.
2. Remove the front fasteners.
3. Loosen but DO NOT remove fasteners (1) and (2).
4. Leave fastener (2) loose and retighten inboard fastener (1), refer to the document on how to reuse fasteners.
5. Remove fastener (2).

6. Reinstall all remaining bolts referring to the pattern shown.
7. Refer to the document for instruction on how to reassemble trim

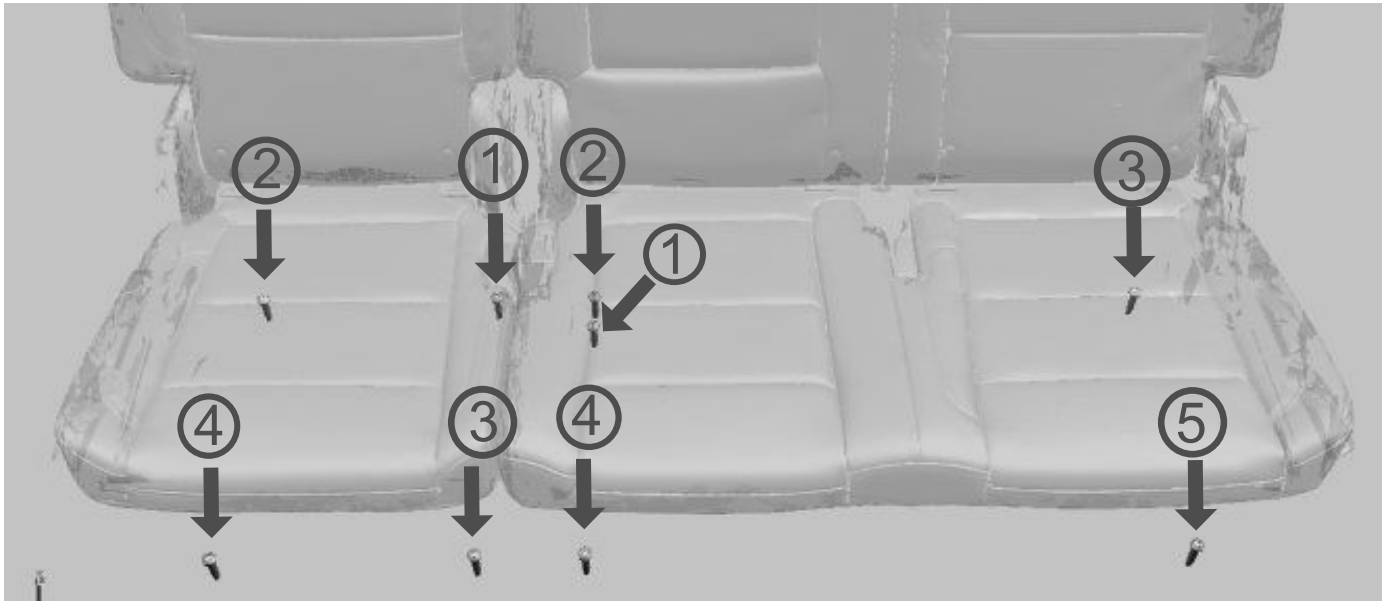
6535676

Bench Seats

1. Refer to document *Rear Seat Removal and Installation* for instruction on how to reuse fasteners or install new ones.
2. Remove the front fasteners.
3. Loosen but DO NOT remove fasteners (1), (2), and (3).
4. Leave fastener (3) loose and retighten inboard fastener (1) and (2), refer to the document on how to reuse fasteners.
5. Remove fastener (3).

6. Reinstall all remaining bolts following the pattern shown.
7. Refer to the document for instruction on how to reassemble trim.
