HYUNDAI Technical Service Bulletin

GROUP CAMPAIGN	NUMBER 25-01-039H
DATE JUNE 2025	MODEL(S) IONIQ 9 (ME1A EV)

SUBJECT: FENDER GARNISH GAP INSPECTION AND REPAIR
(SERVICE CAMPAIGN TDM)

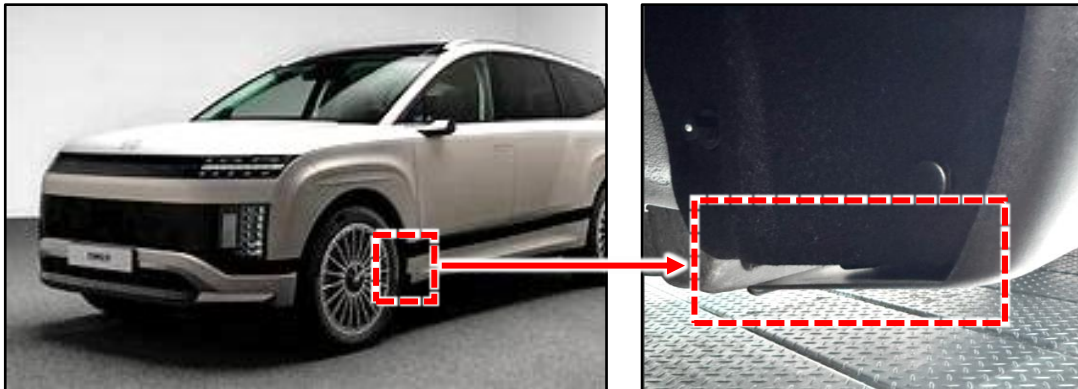
Description: Certain 2026MY IONIQ 9 (ME1A EV) vehicles may have fender garnish clips that were not fully inserted during assembly. If the clips were not properly secured, it may result in a visible gap between the fender garnish and the vehicle body. This may also cause interference when the front door is opened. Follow the procedure in this bulletin to inspect the gap between the fender garnish and vehicle body on both driver and passenger sides and, if necessary, secure the clips.

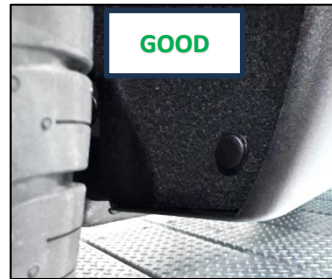
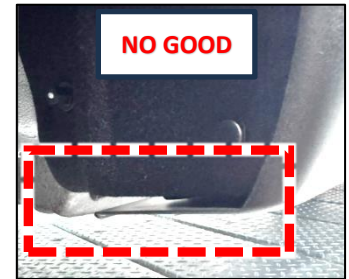
1. Inspect the LH and RH fender garnish where it meets the underbody side panel.

A gap between the fender garnish and the body indicates the underbody clip is **NOT** fully secured.

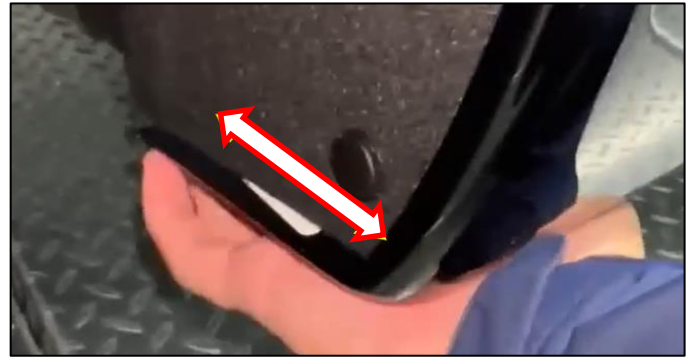
2. Grasp the edge of the LH and RH fender garnish and gently pull outward.

If the garnish is properly secured, it sits flush against the body and does **NOT** move. Any noticeable movement indicates the clip is **NOT** fully locked in place.

3. If either fender garnish is **NOT** fully secured, proceed to **step 1** of the **Fender Garnish Gap Repair Procedure**.
