Technical Service Bulletin (TSB)
4WD Inoperative Or Noisy

REFERENCE:	TSB: 03-005-25 GROUP: 03 - Differential and Driveline	Date:	June 5, 2025	REVISION:	—
VEHICLES AFFECTED:	2025 (DT) RAM 1500 Pickup (RHO Models Only) This bulletin applies to vehicles built on and after December 06, 2024 (MDH 1206XX) and on and before January 29, 2025 MDH 0129XX) equipped with the 3.0L I6 Hurricane HO Twin Turbo w/ESS (Sales Code EFC).	MARKET APPLICABILITY:			
		<input checked="" type="checkbox"/> NA <input type="checkbox"/> MEA <input type="checkbox"/> SA <input type="checkbox"/> IAP <input type="checkbox"/> EE <input type="checkbox"/> CH			
CUSTOMER SYMPTOM:	Customers may experience one or more of the following: <ul style="list-style-type: none"> Noise while in 4WD. 4WD inoperative. 				
CAUSE:	Bent half shaft splines

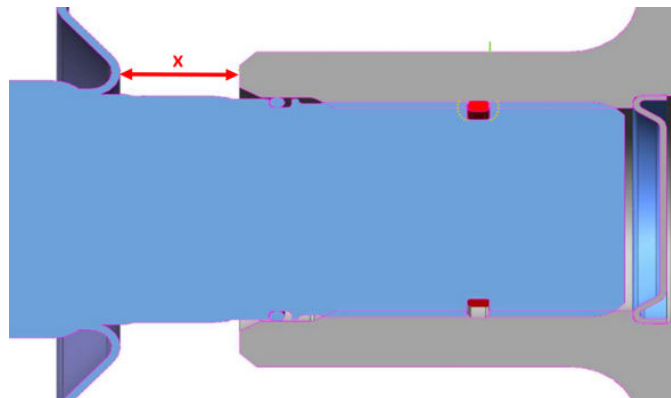
Fig. 1
Area To Measure

- Is the vehicle on the RSU VIN list?
 - YES>>> Proceed to [Step 2](#).
 - NO>>> This bulletin does not apply. Perform further diagnostics.
- Raise and support the vehicle. Refer to the detailed service procedures available in DealerCONNECT/Service Library under: Service Info>04 - Vehicle Quick Reference / Hoisting / Standard Procedure.
- Using a 15mm (19/32 in.) gauge, check the gap between the **left** half shaft and the dust shield of the differential [Fig. 1](#). Note the measurement.

- Using a 3mm (3/32 in.) gauge, check the gap between the **right** half shaft and the dust shield of the differential [Fig. 1](#). Note the measurement.

5. Was either the left half shaft gap greater than or equal to 15 mm (19/32 in.), or the right half shaft gap greater than or equal to 3 mm (3/32 in.)?
 - YES>>> Proceed to [Step 6](#).
 - NO>>> This bulletin does not apply. Use Inspect LOP (02-13-05-9Q) to close the active RSU.
6. Replace the output shafts. Refer to the detailed service procedures available in DealerCONNECT/Service Library under: Service Info> 03 - Differential and Driveline / Shafts, Axle/Drive/Half / Removal and Installation.
