REFERENCE:	TSB: 07-002-25 REV. B GROUP: 07 - Cooling	Date:	June 7, 2025	REVISION:	07-002-25 REV. A
VEHICLES AFFECTED:	<p>2024 - 2026 (B1) Jeep Renegade 2025 - 2026 (H1) Jeep Commander 2025 - 2026 (M1) Jeep Compass This bulletin applies to B1 vehicles built on and after July 10, 2024 (MDH 0710XX) and on or before January 30, 2025 (MDH 0130XX) equipped one of the following:</p> <ul style="list-style-type: none"> **1.3L I4 Turbo MAir DI Engine (Sales Code EYH).** 1.3L I4 Turbo MAir DI Engine w/ESS (Sales Code EYF). 1.3L I4 Turbo Mair DI Eng w/ESS E100 (Sales Code EYJ). <p>This bulletin applies to H1 vehicles built on and after July 09, 2024 (MDH 0709XX) and on or before January 14, 2025 (MDH 0114XX) equipped with one of the following:</p> <ul style="list-style-type: none"> **1.3L I4 Turbo MAir DI Engine (Sales Code EYH).** 1.3L I4 Turbo MAir DI Engine w/ESS (Sales Code EYF). 1.3L I4 Turbo Mair DI Eng w/ESS E100 (Sales Code EYJ). <p>This bulletin applies to M1 vehicles built on and after July 09, 2024 (MDH 0709XX) and on or before January 07, 2025 (MDH 0107XX) equipped with one of the following:</p> <ul style="list-style-type: none"> **1.3L I4 Turbo MAir DI Engine (Sales Code EYH).** 1

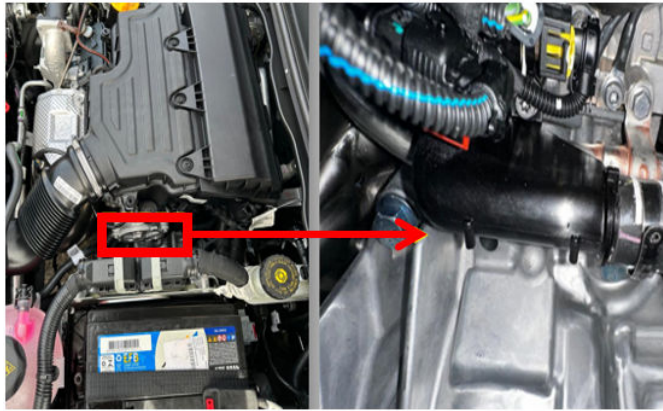
Fig. 1
Inspection Area

3. Inspect the thermostatic valve and it surrounding area for evidence of leaking coolant [Fig. 1](#).

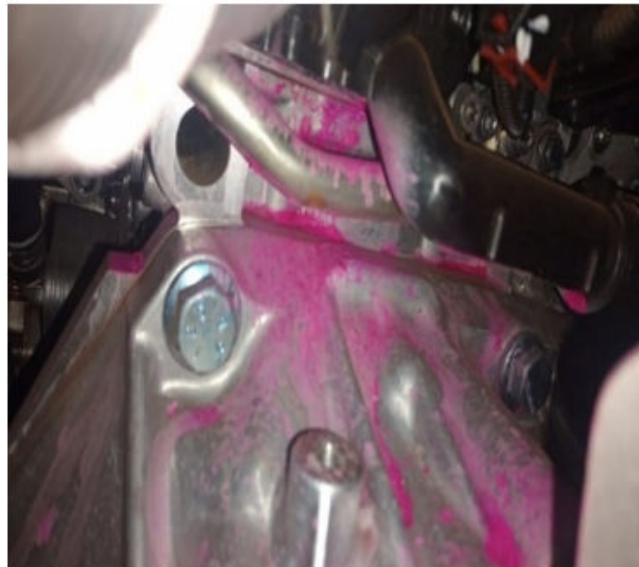
Fig. 2
Coolant Leak

4. Was there a coolant leak found [Fig. 2](#)?

- YES>>> Proceed to [Step 1](#) of the Repair Procedure.
 - NO>>> Use Inspection LOP (07-40-10-91) to close the active RSU and proceed to [Step 5](#).
5. If equipped, install the under engine protection cover. Refer to the detailed service procedures available in DealerCONNECT/Service Library under: Service Info> 7055B54 - Under Engine Protection - Removal/Installation.

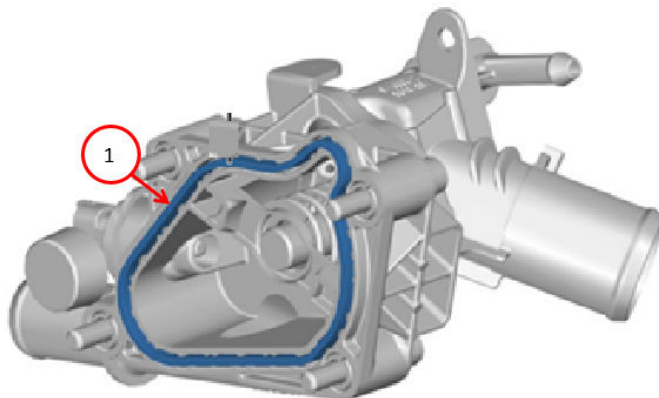
Fig. 3
Thermostatic Valve With Gasket

1 - Thermostatic Valve Gasket

1. Remove the thermostatic valve and replace the thermostatic valve gasket [Fig. 3](#). Refer to the detailed service procedures available in DealerCONNECT/Service Library under: Service Info> 1088C40 - Thermostatic Valve - Removal/Replacement - Including necessary procedures.
