Technical Service Bulletin (TSB)
Alternator Wiring Harness Low Torque

REFERENCE:	TSB: 08-181-25 GROUP: 08 - Electrical	Date:	June 5, 2025	REVISION:	—
VEHICLES AFFECTED:	<p>2024 (B1) Jeep Renegade 2024 - 2026 (H1) Jeep Commander 2024 - 2025 (M1) Jeep Compass 2024 - 2026 (N4) RAM Rampage</p> <p>This bulletin applies to:</p> <ul style="list-style-type: none"> • B1 vehicles built on or after January 03, 2024 (MDH 0103XX) and on or before March 03, 2025 (MDH 0303XX). • H1 vehicles built on or after January 19, 2024 (MDH 0119XX) and on or before April 17, 2025 (MDH 0417XX). • M1 vehicles built on or after January 08, 2024 (MDH 0108XX) and on or before January 03, 2025 (MDH 0103XX). • N4 vehicles built on or after January 05, 2024 (MDH 0105XX) and on or before March 03, 2025 (MDH 0303XX). 	MARKET APPLICABILITY:			
CUSTOMER SYMPTOM:	<p>Customers may comment on one or more of the following:</p> <ul style="list-style-type: none"> • Battery light is illuminated on the Instrument Panel Cluster (IPC). • Vehicle does not start due to a depleted battery.

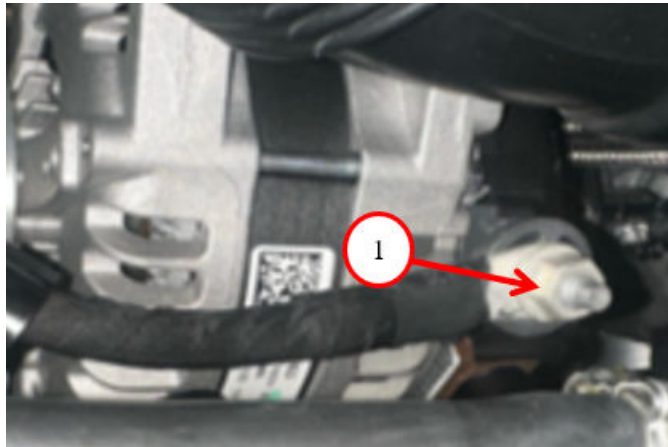
Fig. 1
Alternator B+ Cable Nut

CAUSE:	Loose alternator cable connection

1 - Tighten Alternator B+ Cable Nut

3. Tighten the B+ cable nut to 10 N·m. (8 Ft. Lbs.) [Fig. 1](#).
