<b>REFERENCE:</b>	<b>TSB:</b> 09-014-25 <b>GROUP:</b> 09 - Engine	<b>Date:</b>	June 3, 2025	<b>REVISION:</b>	—
<b>VEHICLES AFFECTED:</b>	2025 (DJ) RAM 2500 Pickup 2025 (D2) RAM 3500 Pickup This bulletin applies to vehicles built on and after December 23, 2024 (MDH 1223XX) and on or before January 20, 2025 (MDH 0120XX) equipped with 6.7L I6 Cummins HO Turbo Diesel Eng (Sales Code ETM).	<b>MARKET APPLICABILITY:</b>			
<b>CUSTOMER SYMPTOM:</b>	Customers may experience the following: <ul style="list-style-type: none"> <li>Audible whistle type noise heard from the engine area.</li> </ul>				
<b>CAUSE:</b>	Manufacturing issue

This bulletin involves tightening the charge air cooler left and right hose clamps to the proper torque specification.

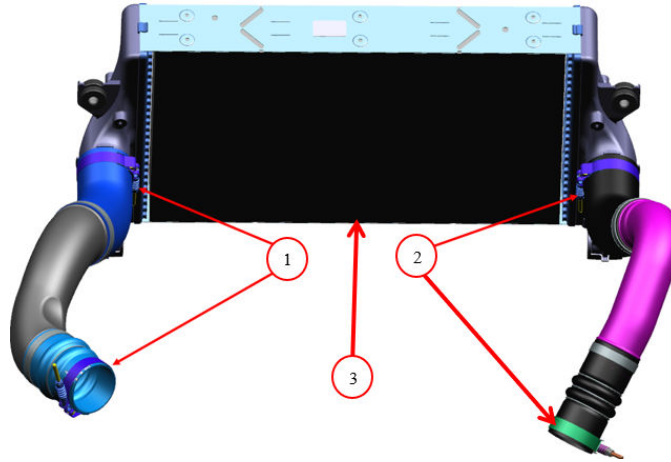
**Fig. 1**  
Charge Air Cooler Hose Clamps

- 1 - Left Side Charge Air Cooler Hose Clamps
- 2 - Right Side Charge Air Cooler Hose Clamps
- 3 - Front Of Charge Air Cooler Assembly

**NOTE:** All charge air cooler hose clamps must be properly torqued. Overview of location and orientation **Fig. 1**. Both of the front clamps can be accessed from underneath the vehicle.
