## STAR ONLINE PUBLICATION

**Case Number: S2509000006**

**Symptom/Vehicle Issue:** Mil-On/Check Engine Lamp (CEL)-On

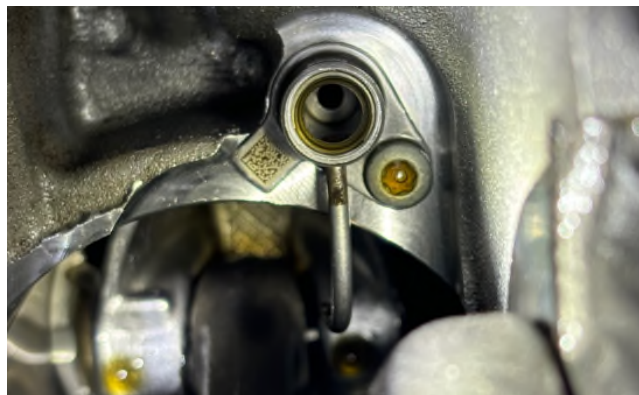
**Fig. 1**

**Discussion:** Perform the published diagnostic routine for the DTC mentioned above. If the routine leads to a possible mechanical/actual low oil pressure condition, perform the following inspection before replacing the oil pump. When at the step in the diagnostics with the oil pan removed, while checking for anything that could restrict oil flow or cause low oil pressure, be sure to inspect the piston oil cooling jets for missing parts. The jets are located at the bottom of EACH cylinder (6 total), secured to the block with one fastener (Fig. 1 shows location AND a "bad" jet).

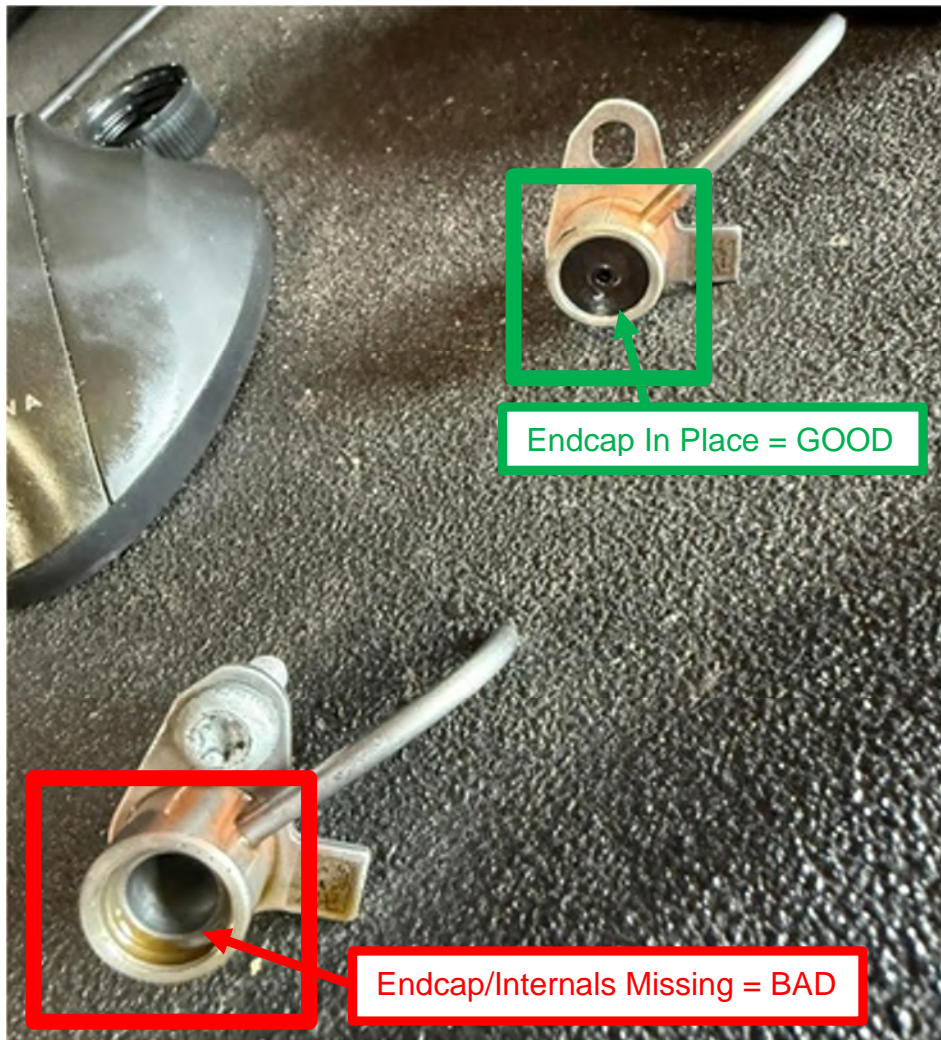
Fig. 2

The picture below (Fig. 2) shows the difference between a “good” jet and a “bad” jet.

Missing jet endcaps/internals can cause a loss of oil pressure sufficient enough to set a P06DD. Any faulty jet assemblies found should be replaced.

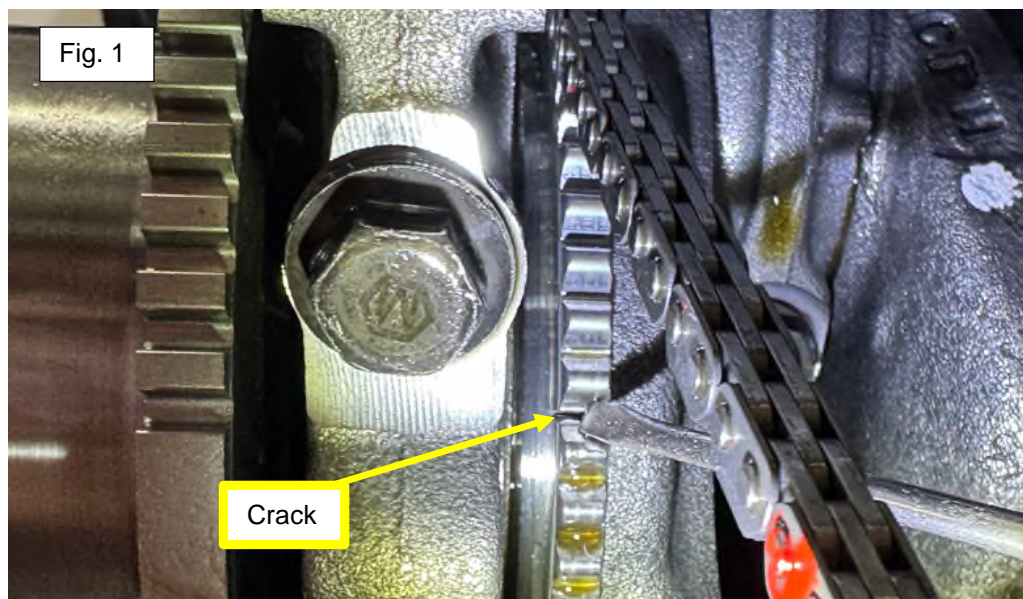
Check the oil pump drive sprocket that rides on the crankshaft for a crack that could cause a loss of tension for the sprocket on the crank, leading to a loss of drive to the oil pump (Fig. 1). Perform a preliminary inspection by attempting to rotate the sprocket by hand. If the sprocket moves on the crank by hand, it is likely cracked, and the long block will need to be replaced.

If unable to move the sprocket by hand, perform a thorough inspection of the sprocket by looking for a crack that would appear between the sprocket teeth (in the valley, between the teeth). Cleaning the sprocket with brake cleaner and shop air may help to make the crack easier to see. Also, check the entire circumference of the sprocket to be sure it is not damaged. If a cracked sprocket is found, replace the long block.

If no cracks are found in the sprocket, replace the oil pump.
