# Service Bulletin

Bulletin No.: 25-NA-090

**Subject: Exhaust Leak Noise After Hard Acceleration**

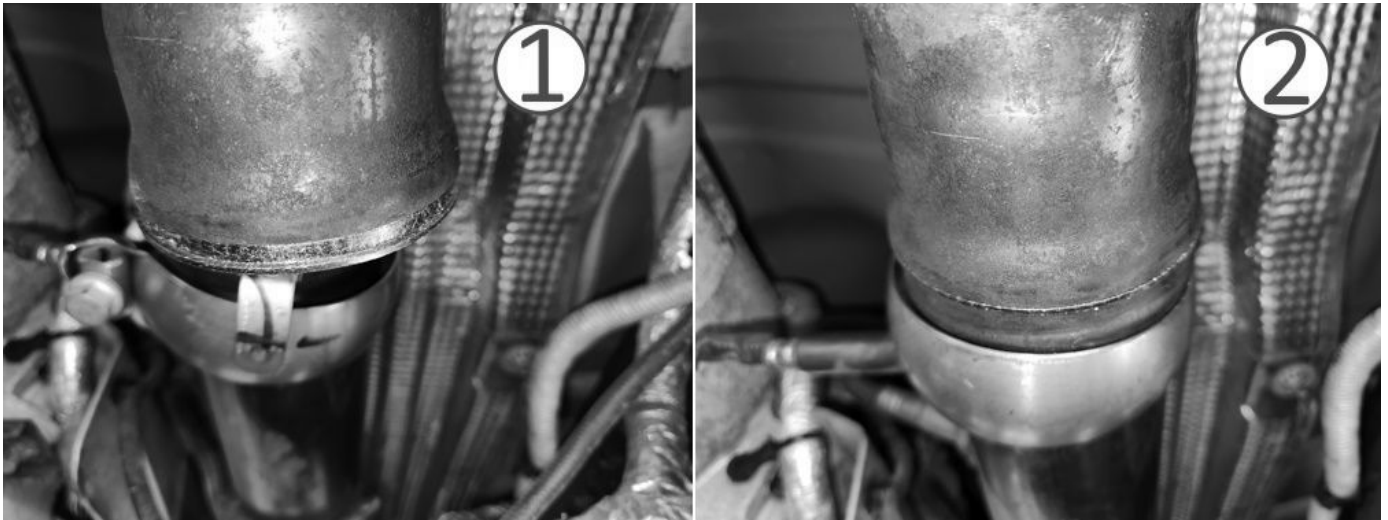
6883456

| <b>Cause</b> | This condition may be caused by a leak at the ball/flange of the connection of the exhaust system to the engine portion of the exhaust system. |

3. Install the new graphite seal on to pipe (1) as shown in the graphic above.
4. Reconnect the pipe (2), verify for proper alignment.
5. Install the new clamp.
  - ⇒ Tighten clamp to 28 N•m (21 lb ft).
6. If any of the exhaust hangers were disconnected, re-secure them.
