GROUP	MODEL
TRA	2024-2025MY Seltos AWD (SP2)
NUMBER	DATE
114	June 2025

TECHNICAL SERVICE BULLETIN

SUBJECT: **AWD/4WD COUPLING ACTUATOR REPLACEMENT (CA2503)**

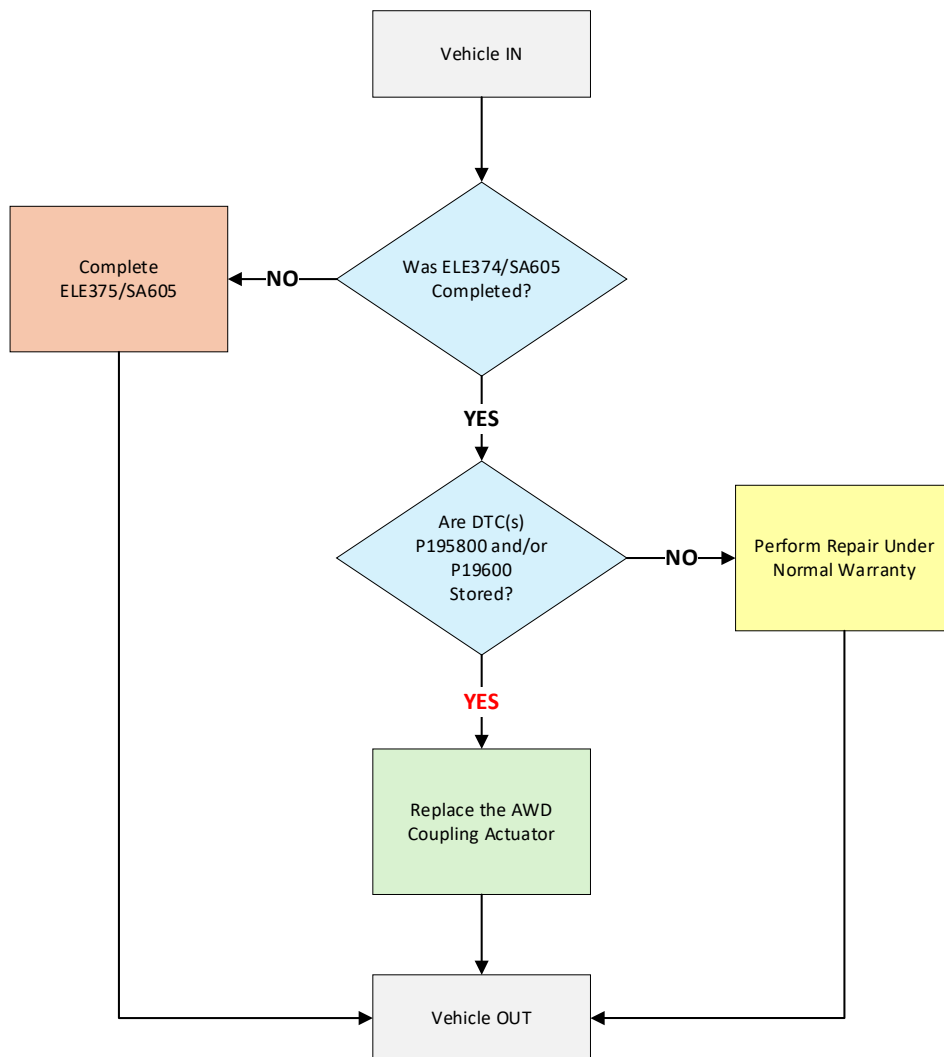
Flowchart:

- TRA114 → Vehicle 'IN' after ELE374 (SA605) was completed AND any of the 'related' DTC's are stored.

One or more 'related' DTC(s) stored:

DTC	DTC Description
P195800	AWD-Torque Error
P196000	AWD-Bleeding Pressure Error
