Technical Journal

Charging Limited to 10A, EVI Release Wire Stuck

REF NO: TJ 37374.1.0	ISSUING DEPARTMENT: Technical Service	CAR MARKET: United States and Canada	
PARTNER: 3 US 7515 Polestar		ISSUE DATE: 2025-05-09	STATUS DATE: 2025-05-15
FUNC GROUP: 3771	FUNC DESC: Cable harness, central high voltage cable	Page 1 of 3

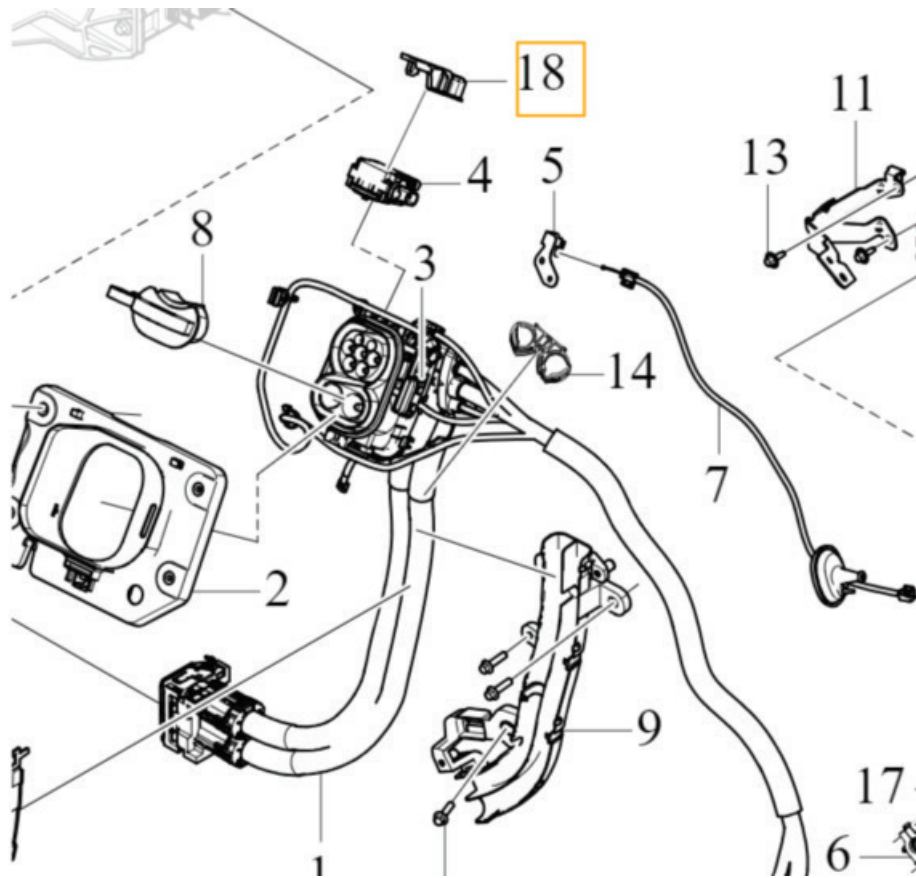
If a customer experiences AC charging limited to 10 Amps and DC charging not working, the root cause may be the EVI release wire not retracting. Please follow the advice under "Service".

In cases where the EVI locking actuator/motor is unable to retract the release wire from the released position (wire pulled out in the trunk) back to the standby position, replace the actuator cover (part #18 in the attachment "Parts Image").

Inspect the EVI release wire in the cargo area.

Follow the VIDA instructions for removal, replacement, and installation of the "Charge connector locking motor."
