Service Bulletin

Bulletin No.: 21-NA-240

Subject: Information on LSY Engine Oil Leaks

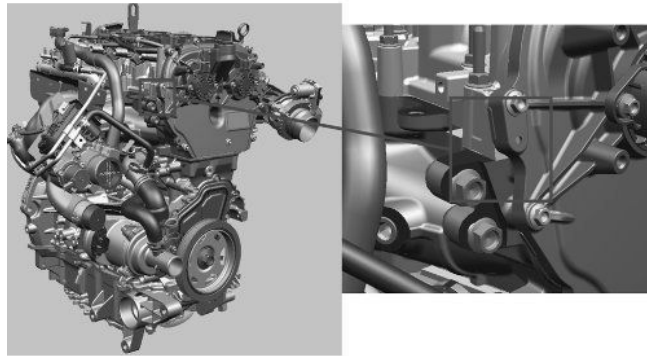
6816616

The graphic above shows the cam carrier T-joint location and where the leak may be potentially coming from.

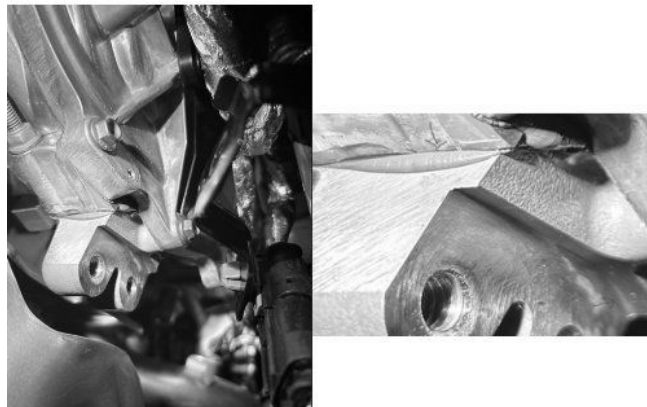
6816617

The graphic above shows the cam carrier T-joint slowly leaking from the adhesive joint.

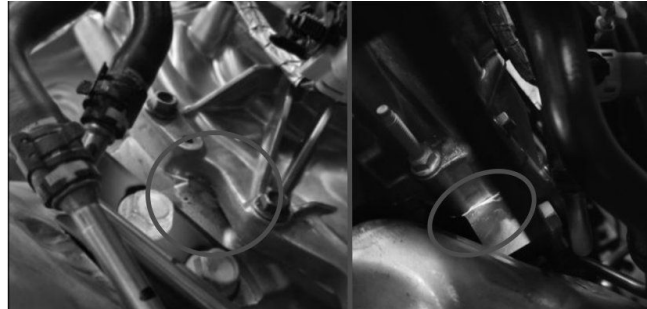
The graphic above shows the cam carrier T-joint area using a black light to highlight the oil dye. 5911107
