# Service Bulletin

Bulletin No.: 23-NA-097

**Subject:** Upper Glove Box Door does not Open when Button is Depressed or Takes Multiple Presses to Open

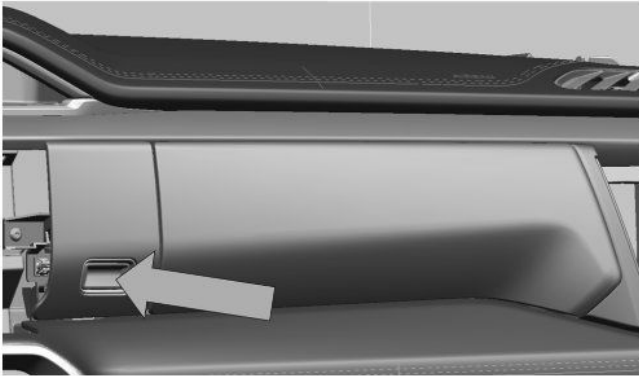
| Cause | <div></div> <div>The cause of the condition may be that the latch pawl is too long and not releasing the door, causing the door to remain closed. 6361432</div> |

| Correction | If the door will not open, you will need to file/sand down the latch pawl following the Service Procedure outlined below. |
