SIB 32 06 25

KNOCKING/THUMPING NOISE FROM STEERING SYSTEM

MODEL

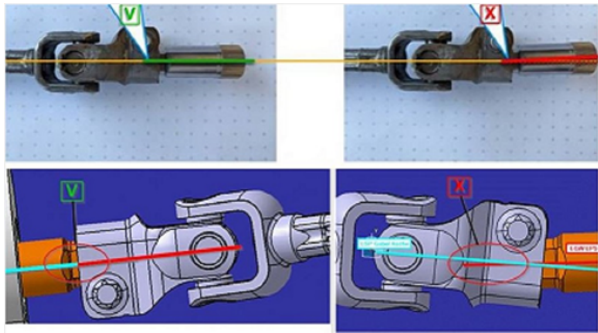
Tension in the steering column components, steering shaft universal joint to steering gear input shaft.

Re-alignment of the steering shaft universal joint to steering gear input shaft.
