SIB 41 04 25

SLOSHING WATER INSIDE THE VEHICLE'S BODY

2025-06-02

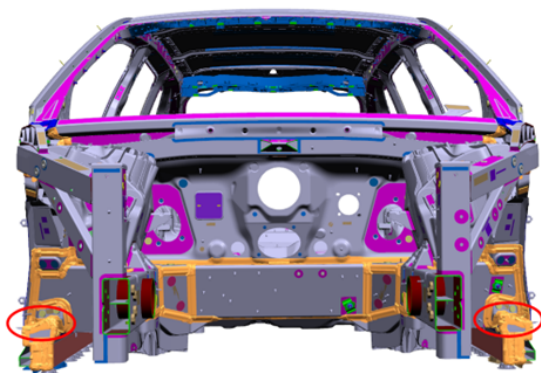
The PVC seam sealer on the front right and/or left inner wheel weld area is not completely sealed (**circled in red**, showing the body shell’s firewall and frame rails looking rearwards).

Reseal the seam sealer on the (affected side) front right and/or left inner weld at the wheelwell.

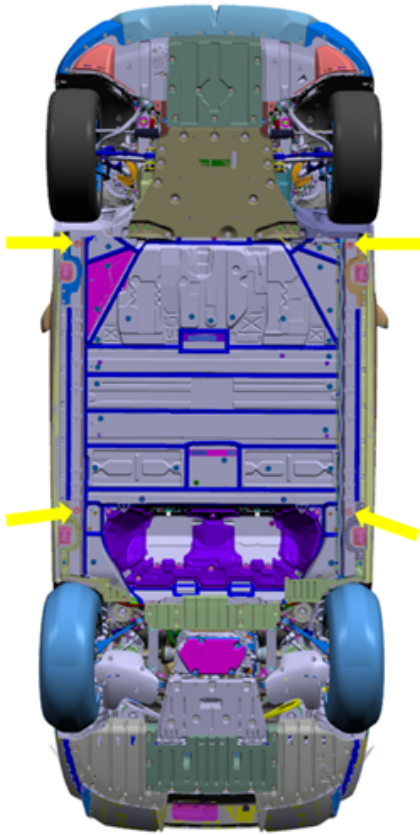
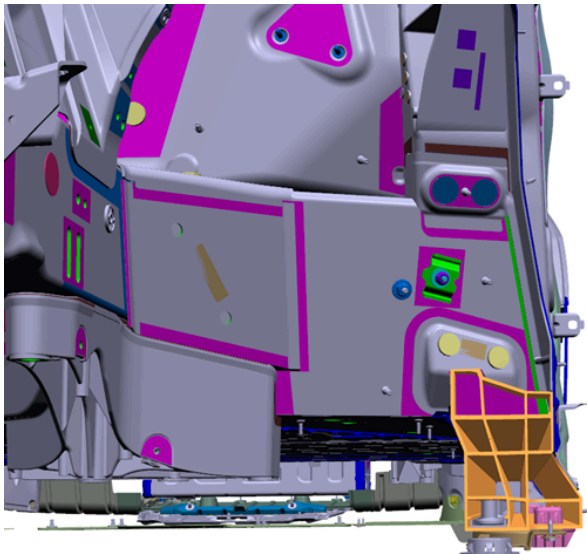
1. Verify the customer’s concern.
2. Drain the water from the vehicle’s body by removing the front/rear corner bolts that secure the HV battery to the vehicle on the side in which the water is trapped (yellow arrows pointing to the applicable bolts).

Photo shows the cavities in which the water is trapped (highlighted in orange).

The driver's side is viewed looking rearward for this procedure. The passenger side is similar.

Note: Any of the four bolts removed need to be replaced and properly torqued. Review repair instructions 61 25 010 for torque spec information.

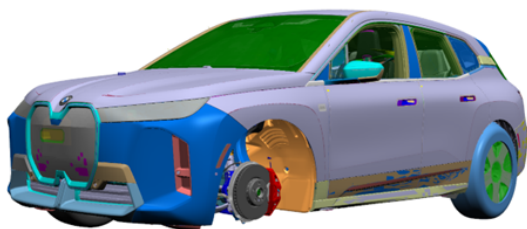
3. Remove the front inner fender liner(s) (highlighted in orange) from the affected side of the vehicle following repair instructions 51 71 039 listed in ISTA/AIR.

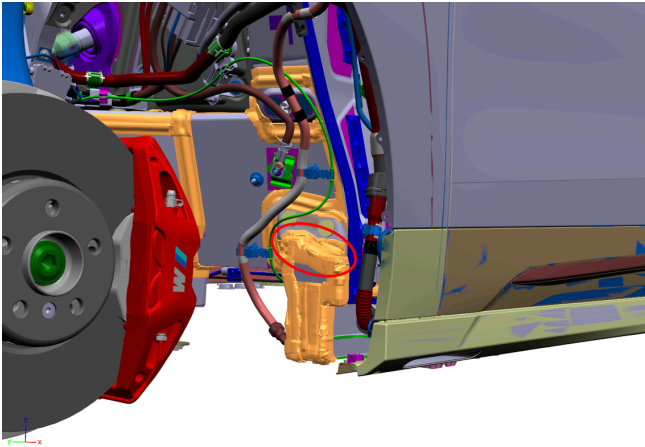
Photo is showing where the current seam sealer (circled in red) should be cleaned and where new seam sealer should be applied.

Note: DO NOT remove the current/original seam sealer.
