SIB 61 09 25

WINDSHIELD WIPING QUALITY IS REDUCED OR A POPPING /  
CLICKING SOUND IS OBSERVED

2025-06-06

E-Series	Model Description	Production Date
G45	X3 Sports Activity Vehicle	October 15, 2024 – January 28, 2025

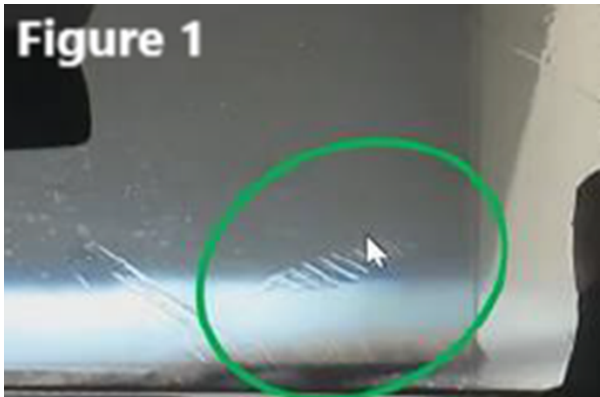
Wiping quality degrades with increasing speed (Figure 1).

The wiper console may be cracked and/or broken due to the manufacturing process.

Use a borescope or mirror to inspect the wiper console for cracks and/or broken mounts.

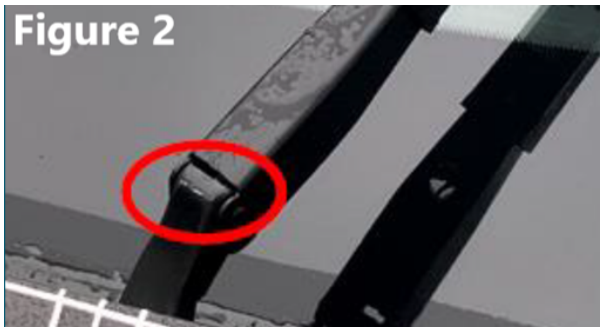
Wiper arm contacts the hood, customer may hear a “clicking” noise (Figure 2).

8. Inspect the area’s where the wiper arm may have contacted the hood. Repair any paint damage caused by a wiper defect.

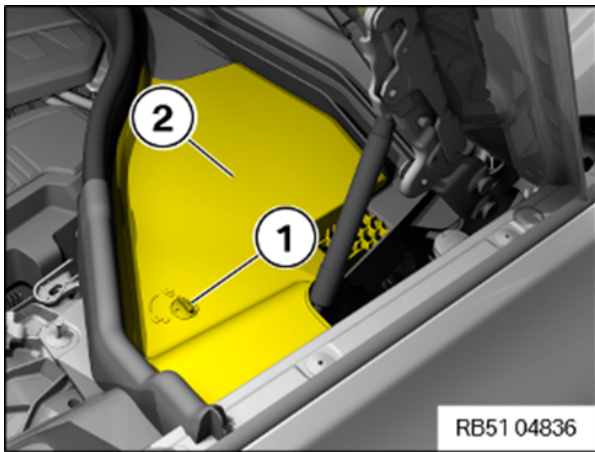
1. Remove the cover of the engine compartment at the left rear (driver's side).

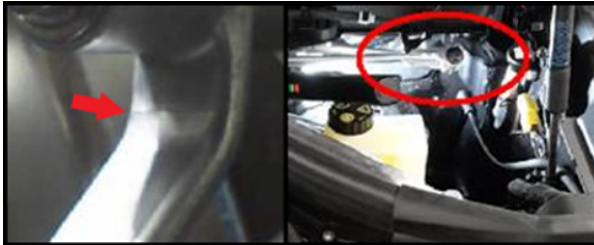
2. Using a borescope or mirror, check whether the wiper console is broken or cracked around the rotary housing. (driver side)

**Yes:** Replace the wiper console following repair instructions “**Replacing the console for the windshield wiper system complete with motor**” 61 61 271 | REP-REP-P-6161271-G45 - V.3.

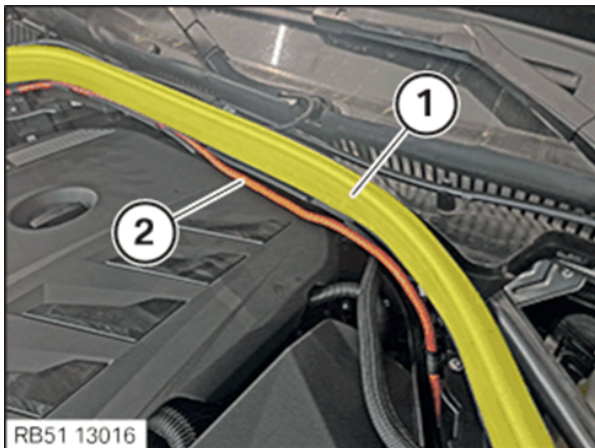
**No:** Perform further inspection of the wiper console for cracks and/or breakage at the upper mounting brace near the center of the bulkhead.

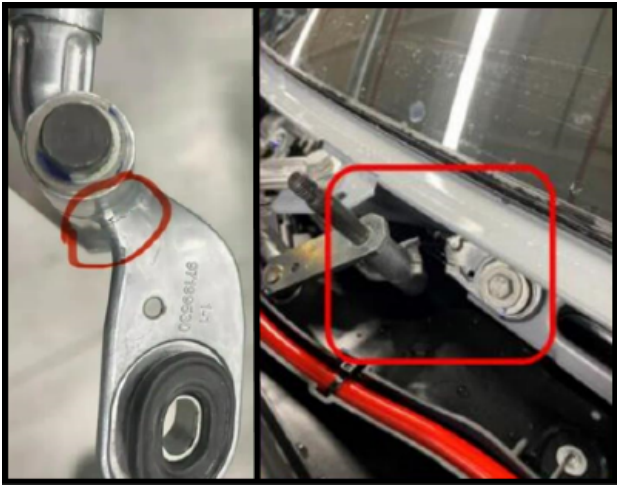
6. Using a borescope or mirror, inspect the wiper console around the upper mounting brace at the center of the bulkhead.

7. If damage or cracks are discovered, replace the wiper console following repair instructions  
**“Replacing the console for the windshield wiper system complete with motor”** 61 61 271 | REP-REP-P-6161271-G45 - V.3.
