SIB 63 03 25

DELIVERY STOP: LOW BEAM HEADLIGHT ADJUSTMENT

E-Series	Model Description	Production Date	Affected Option Code
G45	X3 Sports Activity Vehicle	July 24, 2024 – April 28, 2025	552 (Full LED Lights with Cornering Lights) or 3MF (M Shadowline Lights)

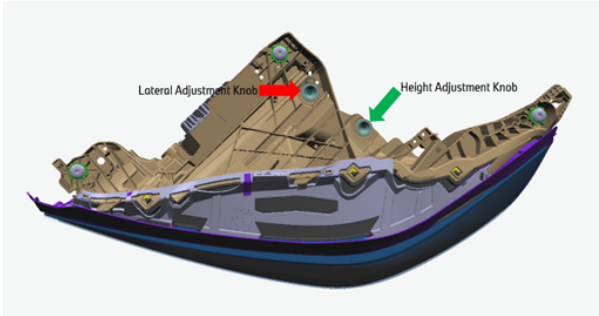
Photo is showing two adjusting knobs but **ONLY** the height adjustment knob (green arrow) needs to be adjusted.

Note: There is no need to adjust the lateral adjustment knob (red arrow).

Driver's side unit shown, looking downwards.
