SIB 72 01 25

2025-06-10

G1X/G3X FALSE ALERT RF SEAT OCCUPIED W BELT UNBUCKLED-EXTENDED LIMITED WARRANTY

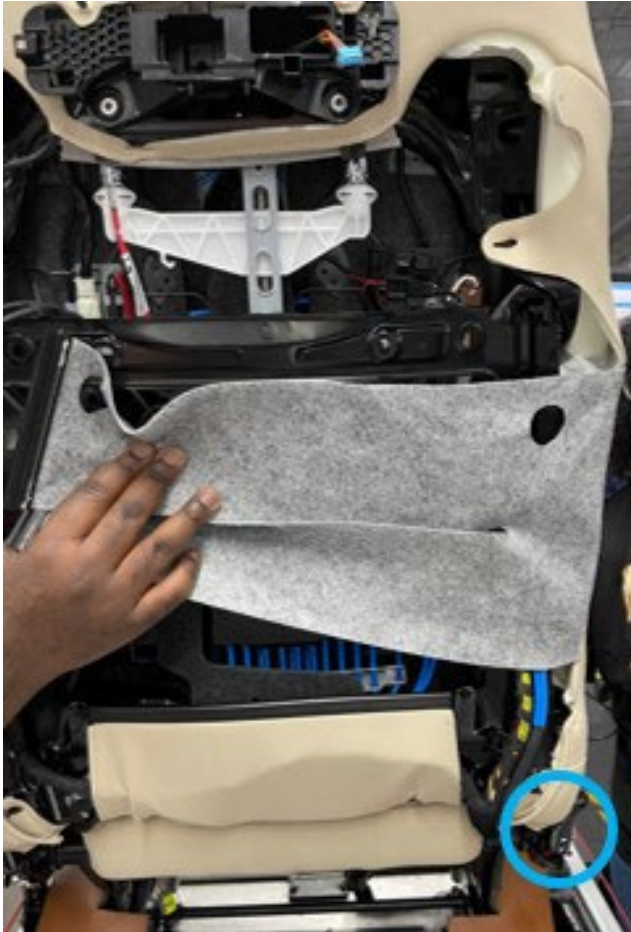
3. Prior to replacing components, inspect the connection of the CIS mat ground wire to the structure at the lower right side of the backrest (circled).

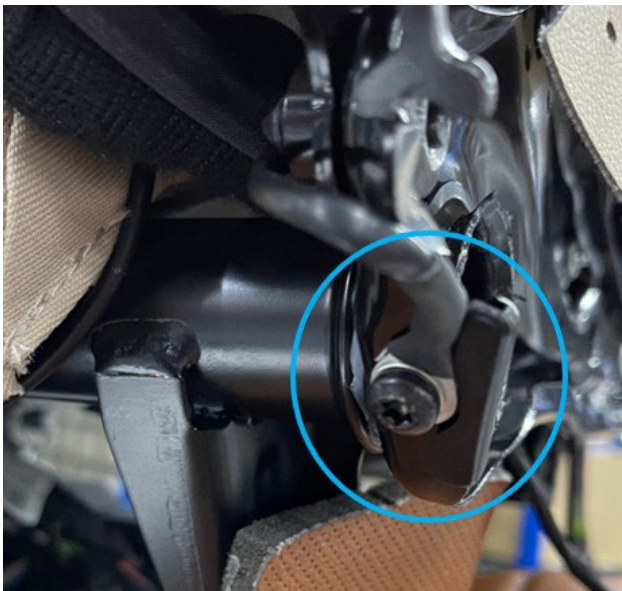
The eyelet on the ground wire should make solid connection to the structure with no free play.

If free play is identified, repair as needed.

Secure ground screw to eliminate free play to the structure.

Torque specification: **4.5 Nm (+/-0.5)**

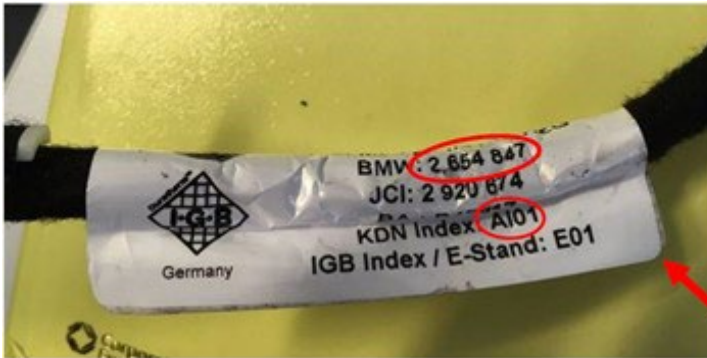
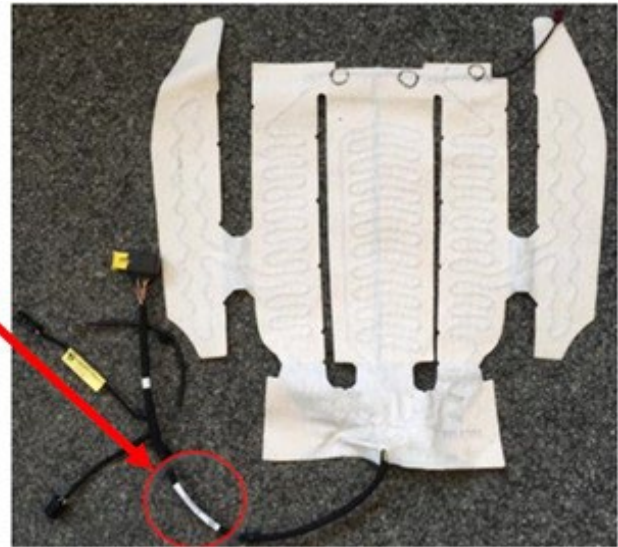
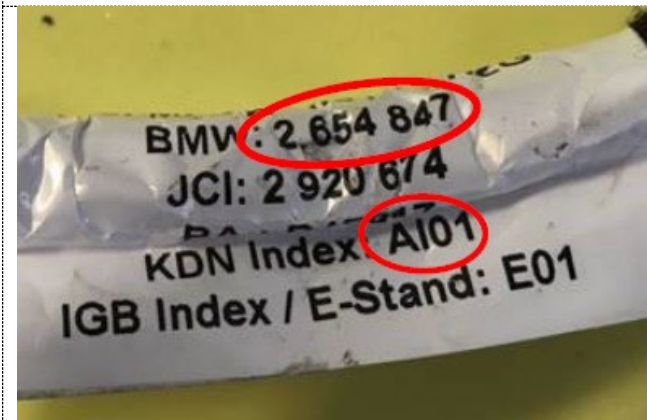
In this example, the BMW Part Number 2 654 847 is shown (circled).

The corresponding KDN (Revision) Index number "AI01" is shown (circled).
