SIB 72 02 25

2025-06-11

G0X/G20 FALSE ALERT RF SEAT OCCUPIED W BELT UNBUCKLED- EXTENDED LTD WARRANTY

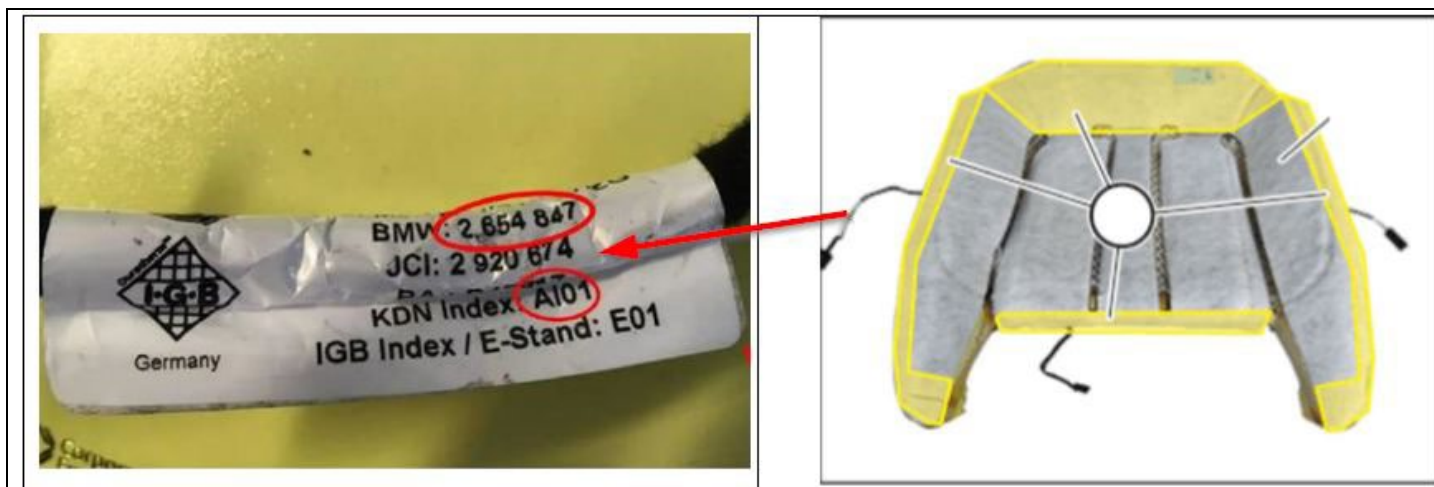
To access the label's information, loosen seat mounting, open the central connector, fold seat to the back, completely.

In this example, the BMW Part Number 2 654 847 is shown (circled).

The corresponding KDN (Revision) Index number "AI01" is shown (circled).

- If the **Change Index number is lower / less than (<)** what is specified in the table above for the matching vehicle seat option(s) and part number, then:
 - A.** Replace the front passenger's seat heating/CIS mat.
 - If the **Change Index number is equal to (=), or greater than (>)** what is specified in the table above for the matching vehicle seat option(s) and part number, then:
 - B.** Refer to Step # 7 in this Service Information Bulletin.
6. Check the validity of the seat CIS mat replacement repair by:
- Ensuring no faults or check control messages are displayed
 - Confirming operation of the seat occupancy function with an adult in the seat
