SIB 72 03 25

## G01/G02 FALSE ALERT RF SEAT OCCUPIED W BELT UNBUCKLED-EXTENDED LIMITED WARRANTY

This Service Information bulletin (Revision 2) supersedes SI B72 03 25 **dated May 2025**.

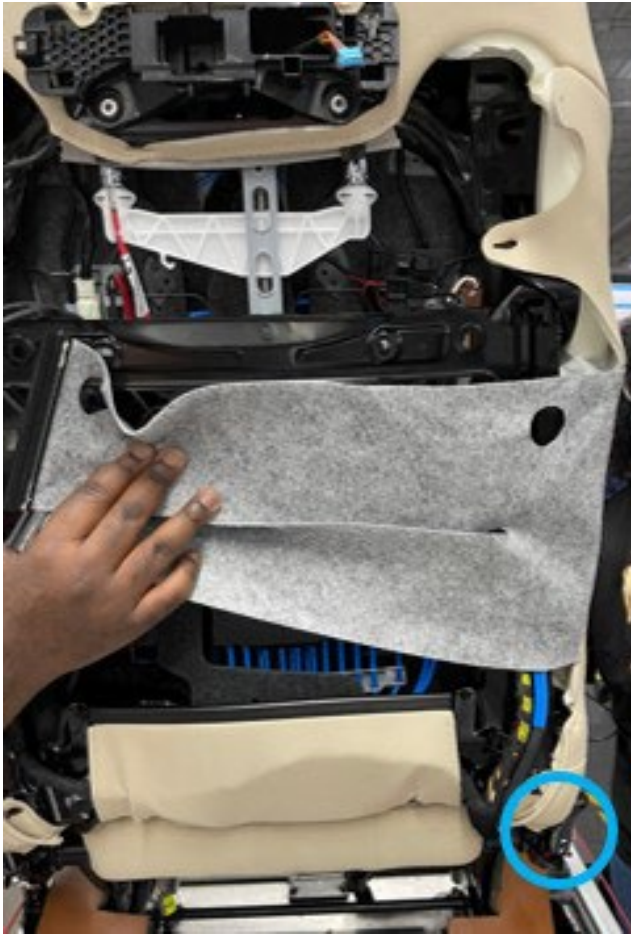
3. Prior to replacing components, inspect the connection of the CIS mat ground wire to the structure at the lower right side of the backrest (circled).

The eyelet on the ground wire should make solid connection to the structure with no free play.

If free play is identified, repair as needed.

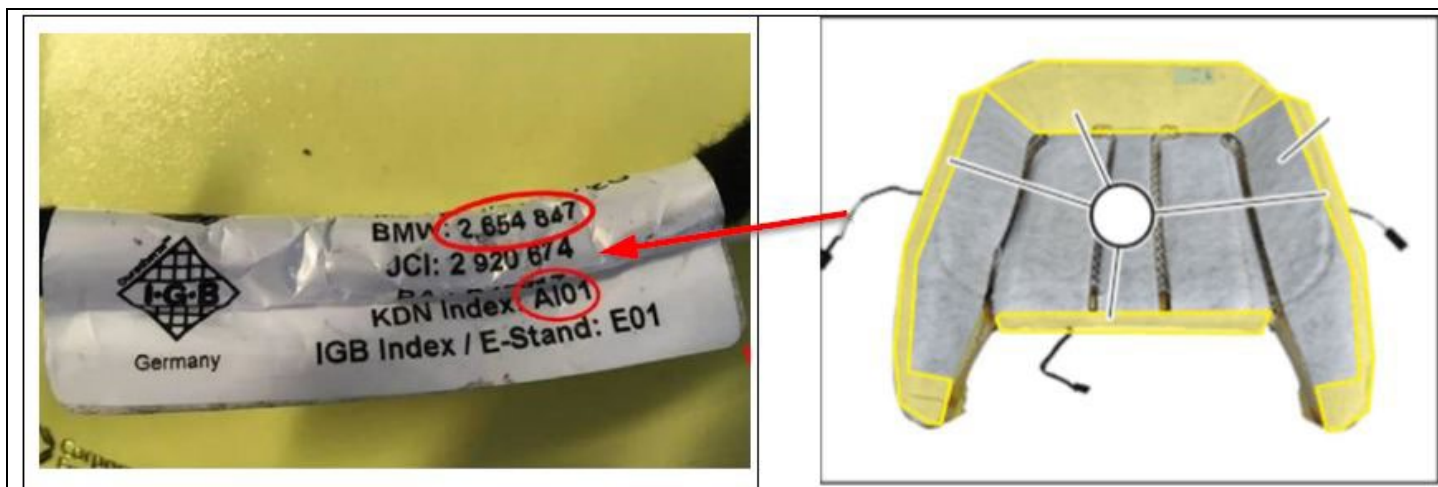
In this example, the **BMW Part Number 2 654 847** is shown (circled).

**The corresponding KDN (Revision) Index number "AI01" is shown (circled).**

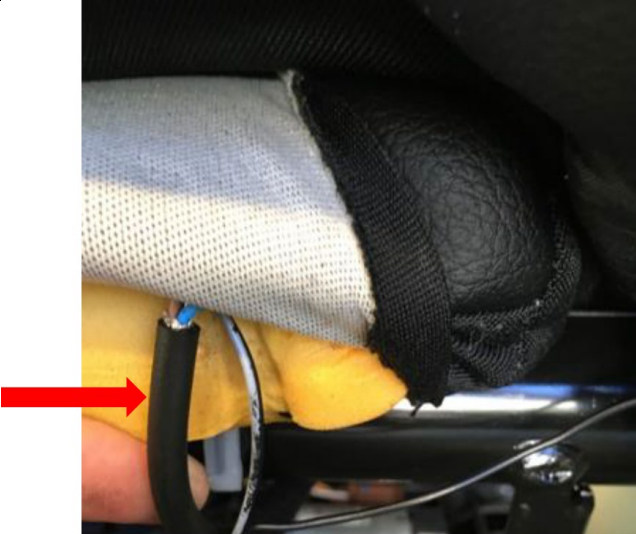
<p>The following cables/cable assemblies are now exposed:</p> <ul style="list-style-type: none"><li>- Cable assembly (4 cables in a rubber jacket) including shielding.</li></ul> <p>This is the wiring that will be modified</p>
