SIB 72 04 17

2025-06-11

F90 FALSE ALERT RF SEAT OCCUPIED W BELT UNBUCKLED- EXTENDED LTD WARRANTY

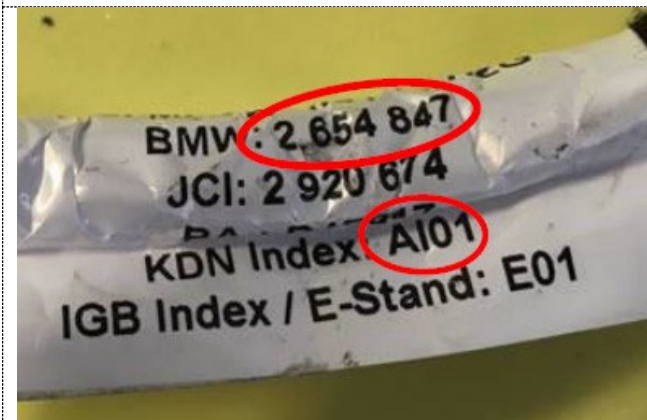
In this example, the BMW **Part Number 2 654 847** is shown (circled).

The corresponding KDN (Revision) Index number "A101" is shown (circled).

To access the label's information, loosen seat mounting, open the central connector, fold seat to the back, completely.
