STAR ONLINE PUBLICATION

Case Number: S2508000036 Rev. A

Symptom/Vehicle Issue: The Occupant Restraint Controller (ORC) Will Set The B2204-00 DTC In Unknown Status (pending), For B2204-00 ECU Configuration Mismatch

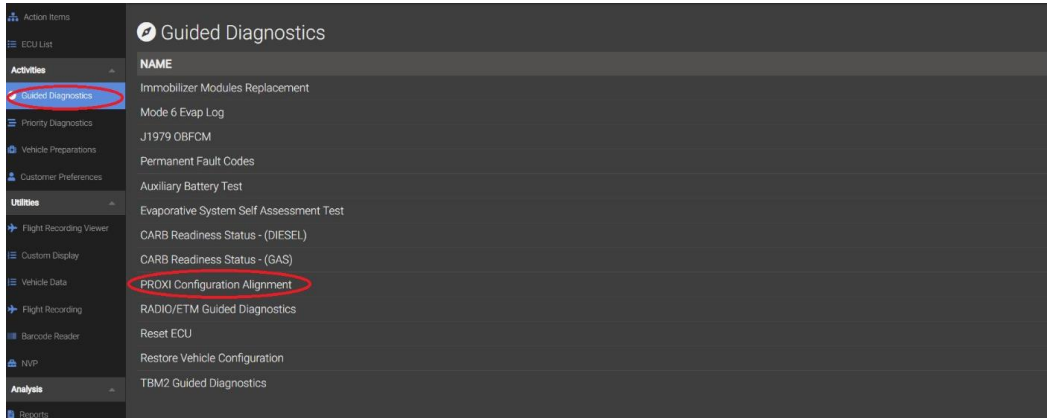
1- In Guided Diagnostics, Perform “PROXI Configuration Alignment”
