STAR ONLINE PUBLICATION

Case Number: S2508000051

Symptom/Vehicle Issue: Malfunction Indicator Lamp (MIL) on, Wheel End Disconnect (WED)
Diagnostic Trouble Codes (DTCs)

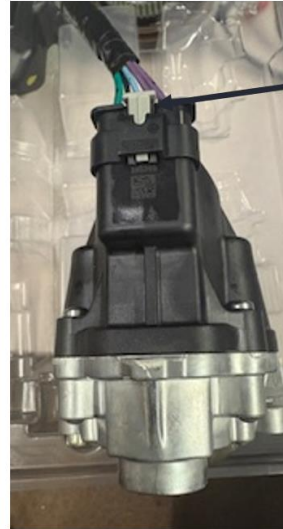
STLA LARGE WED Pinout (KM, LB, EJ)

USCAR P IN	1	2	3	4	5
FUNCTION	SOL (-)	SENS +5V	SENS OUT	SENS GND	SOL (+)

METAL CONNECTOR PINOUT
SCALE 3:1

CONTROL LOGIC	
COMMAND	CURRENT POLARITY
CONNECT	POSITIVE
DISCONNECT	NEGATIVE

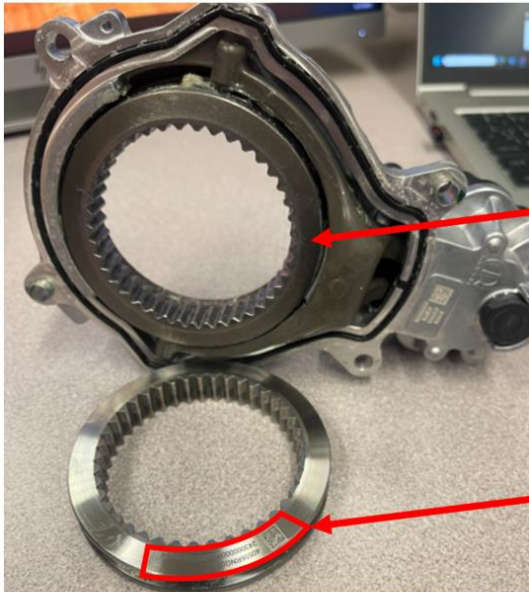
Do not reinstall Dog Ring if missing one or both shift pads

Barcode and Part Numbers NOT visible from this side when ring is installed

Barcode and Part Numbers
