# 2025 Ram ProMaster (VF) - Front Axle ABS Light on After Wheel Speed Sensor Replacement

## MY 2022 - 2025 (All Models) - Coolant Reservoir Leak Analysis

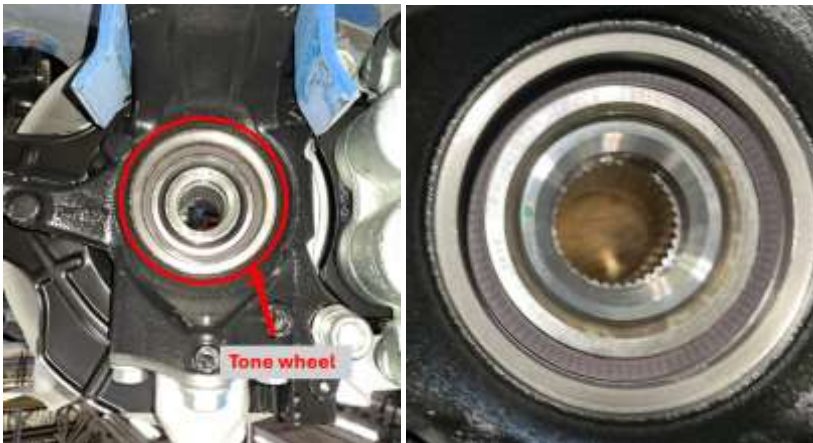
We have received warranty claims that have stated that the ABS ESC lights are on after Wheel Speed Sensor replacement.

7. After completing the previous steps, the access to the Tone Wheel area will be possible, clean the area to remove particles (All area inside red circle), re-assembly the parts and verify that the issue is not present.

If the issue returns, replace the Tone Wheel assembly.

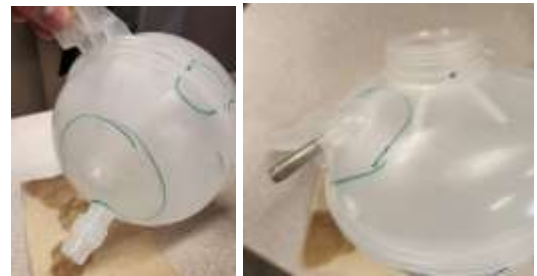
- For any deformation related defects, circle the affected regions with a sharpie or paint marker, example on the right:
