<b>REFERENCE:</b>	<b>TSB:</b> 08-185-25 <b>GROUP:</b> 08 - Electrical	<b>Date:</b>	June 11, 2025	<b>REVISION:</b>	—
<b>VEHICLES AFFECTED:</b>	2024 - 2025 (WS) Jeep Wagoneer / Grand Wagoneer			<b>MARKET APPLICABILITY:</b> <input checked="" type="checkbox"/> NA <input type="checkbox"/> MEA <input type="checkbox"/> SA <input type="checkbox"/> IAP <input type="checkbox"/> EE <input type="checkbox"/> CH <b>NOTE:</b> This bulletin applies to North America market.	
<b>CUSTOMER SYMPTOM:</b>	<p><b>Customers must experience a Malfunction Indicator Lamp (MIL) illumination and the vehicle must exhibit/set one or more of the following Diagnostic Trouble Codes (DTCs) as active:</b></p> <ul style="list-style-type: none"> <li>• C1593-00 - Steering Torque Sensor Circuit.</li> <li>• C0051-64 - Steering Angle Sensor (EPS) - Signal Plausibility Failure.</li> </ul> <p><b>Customers may experience one or more of the following:</b></p> <ul style="list-style-type: none"> <li>• "EPS" indicator is illuminated on the Instrument Panel Cluster (IPC).</li> <li>• Partial or full loss of power steering assist.</li> <li>• Once the DTC is set, the reduction or loss of assist will remain for the remainder of the key

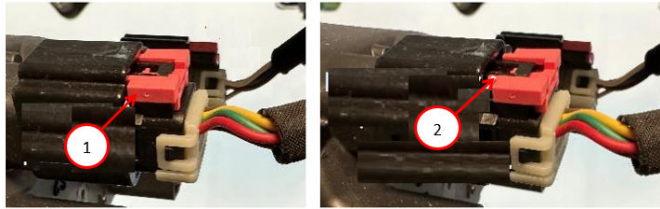
**Fig. 1**  
Connector Tab Locking Feature

1. Raise and support the vehicle. Refer to the detailed service procedures available in DealerCONNECT/ Service Library under: Service Info>04 - Vehicle Quick Reference / Hoisting / Standard Procedure.
2. Inspect the connector tab lock feature on the torque sensor harness connector to confirm if it is in the fully engaged position [Fig. 1](#).

1 - Connector Tab Lock Fully Engaged  
2 - Connector Tab Lock Not Fully Engaged

3. Is the connector tab lock feature in the fully engaged position [Fig. 1](#)?
  - YES>>> Proceed to [Step 4](#).
  - NO>>> Proceed to [Step 6](#).
4. Apply a small load to pull the connector by hand in the disengagement direction to confirm that the connector is fully latched.
5. Does the connector come loose or disconnect?
  - YES>>> Proceed to [Step 6](#).
  - NO>>> This bulletin does not apply. Further diagnose should be performed.
6. Fully disconnect the connector.
7. Inspect the inside of the connector to ensure the latching feature is not damaged [Fig. 2](#).

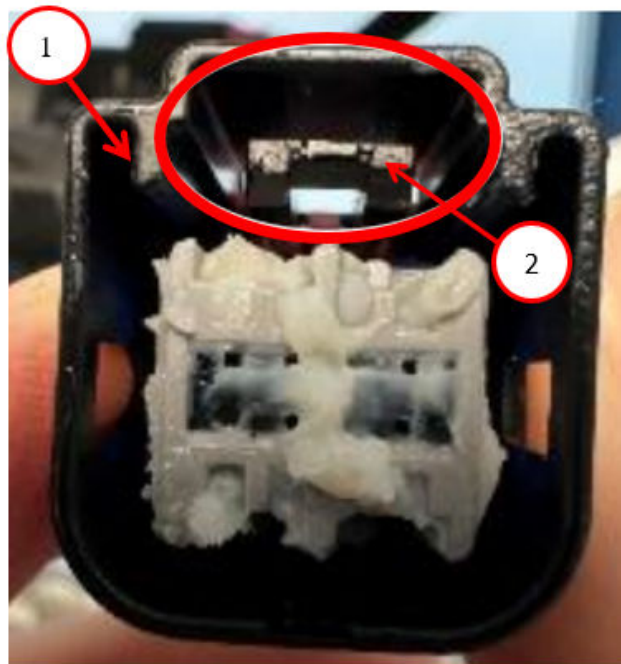
**Fig. 2**  
Inside Connector

1 - Connector Assembly  
2 - Tab Lock Latch

8. Is a damaged connector tab lock latch causing the connector tab lock feature to not be able to fully engage?
- YES>>> Proceed to [Step 9](#).
  - NO>>> Proceed to [Step 10](#).
9. Replace the Electric Power Steering (EPS) gear. Refer to the detailed service procedures available in DealerCONNECT/Service Library under: Service Info> 19 - Steering / Gear / Removal and Installation. After EPS gear replacement, proceed to [Step 16](#).
10. Inspect the grease pattern on both halves of the connector to ensure that grease is present on the connector [Fig. 3](#).

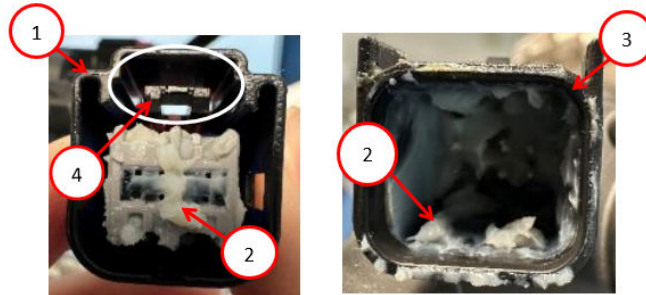
**Fig. 3**  
Connector Halves

- 1 - Connector  
2 - Grease  
3 - Connector Mating Header  
4 - Connector Tab Lock Latch

11. Is grease present on the both halves of the connector?
- YES>>> Proceed to [Step 13](#).
  - NO>>> Proceed to [Step 12](#).
12. Apply a small amount of grease to the marked connectors.
13. Inspect the connector mating header for any excessive grease build up [Fig. 4](#).

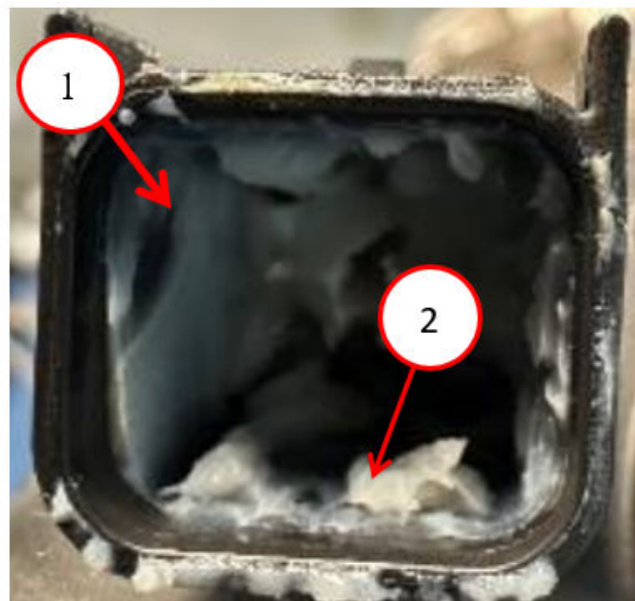
**Fig. 4**  
Connector Mating Header

- 1 - Connector Mating Header  
2 - Grease

14. Is grease build up seen in the connector mating header [Fig. 3](#)?

- YES>>> Proceed to [Step 15](#).
- NO>>> Proceed to [Step 17](#).

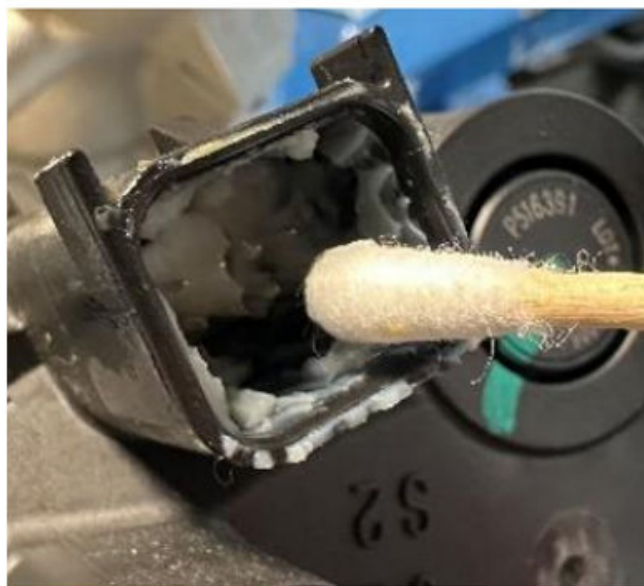
**Fig. 5**

Remove Excess Grease

16. Using a cotton swab, carefully wipe away any grease build up from the inside walls of the mating header near the front face [Fig. 5](#).

**When wiping away grease from the connector walls, avoid touching the metal pins in the header to prevent damage.**
