**Technical Service Bulletin (TSB)**  
**Fuel Leaking From Fuel Heater Harness Connector**

<b>REFERENCE:</b>	<b>TSB:</b> 14-014-25 <b>GROUP:</b> 14 - Fuel	<b>Date:</b>	June 12, 2025	<b>REVISION:</b>	-
<b>VEHICLES AFFECTED:</b>	<b>2025 (DJ) RAM 2500 Pickup</b> <b>2025 (D2) RAM 3500 Pickup</b> This bulletin applies to the vehicle built on or before February 13, 2025 (MDH 0213XX) equipped with 6.7L I6 Cummins HO Turbo Diesel Eng (Sales Code ETM).			<b>MARKET APPLICABILITY:</b> <input checked="" type="checkbox"/> NA <input type="checkbox"/> MEA <input type="checkbox"/> SA <input type="checkbox"/> IAP <input type="checkbox"/> EE <input type="checkbox"/> CH <b>NOTE:</b> This bulletin applies to North America markets.	
<b>CUSTOMER SYMPTOM:</b>	<b>Customers may comment on the following:</b> <ul style="list-style-type: none"> <li>Fuel is leaking.</li> </ul>				
<b>CAUSE:</b>	Leaking O-ring

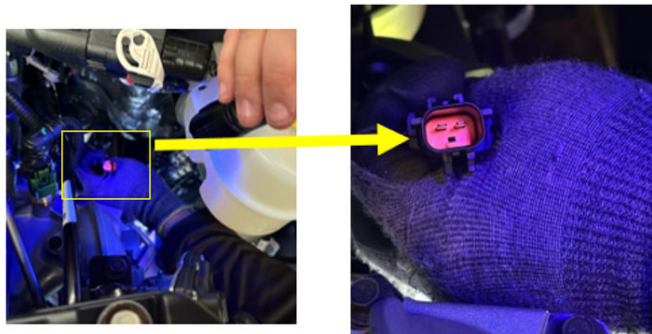
**Fig. 1**  
Fuel Heater Connector Inspection

1. Disconnect the wire harness from the fuel heater connector.
2. Using a UV blacklight, inspect for signs of fuel intrusion or residual diesel fuel in the connector [Fig. 1](#).

3. Is fuel intrusion or residual diesel fuel found in the connector?
  - YES>>> Proceed to [Step 4](#).
  - NO>>> This bulletin has been completed. Use Inspection LOP (14-40-03-90) to close the active RSU.
4. Replace the fuel heater. Refer to the detailed service procedures available in DealerCONNECT/Service Library under: Service Info> 09 - Engine, 6.7L Diesel / Fuel System / Heaters / Removal and Installation.
