HYUNDAI Technical Service Bulletin	GROUP BODY ELECTRICAL	NUMBER 25-BE-013H
	DATE JUNE 2025	MODEL(S) SEE BELOW
SUBJECT: CONNECTED CAR NAVIGATION COCKPIT (CCNC) LITE REPLACEMENT FOR BLUETOOTH CONNECTION IMPROVEMENT

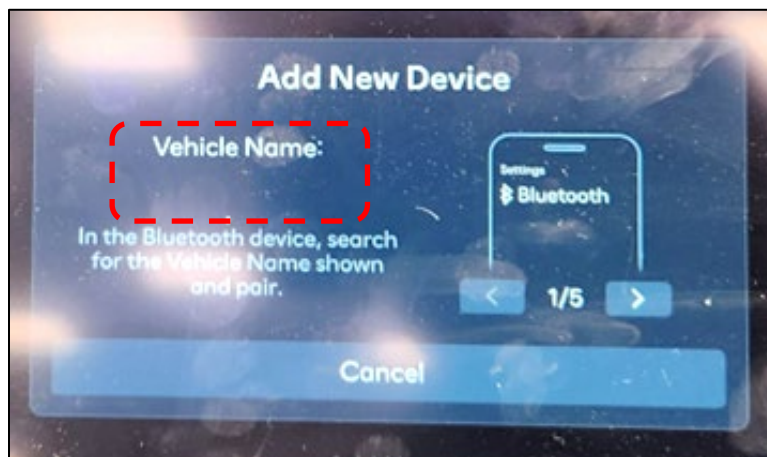
Description: Certain vehicles with the Connected Car Navigation Cockpit (ccNC) Lite units may exhibit connection issues with Bluetooth and wireless phone projection. The vehicle's name may also not appear when trying to connect via Bluetooth. This condition may be caused by an internal fault inside the ccNC unit. Follow the procedures in this TSB to replace the ccNC unit in affected vehicles.

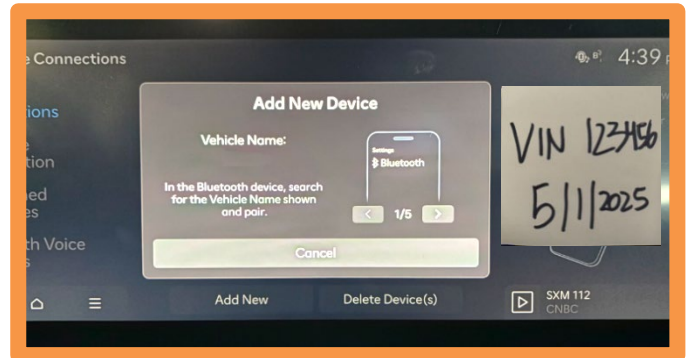
If vehicle name is missing or Bluetooth connection issues are found, please proceed with procedure.

Using STUI, take a photo of Bluetooth device/connection screen showing the missing vehicle name with the last 6 digits of the VIN and the date of repair on a piece of paper.

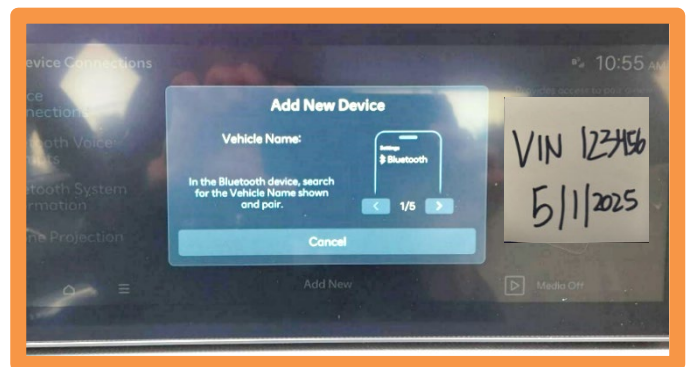
If vehicle name is missing or Bluetooth connection issues are found, please proceed with procedure.

Using STUI, take a photo of Bluetooth device/connection screen showing the missing vehicle name with the last 6 digits of the VIN and the date of repair on a piece of paper.

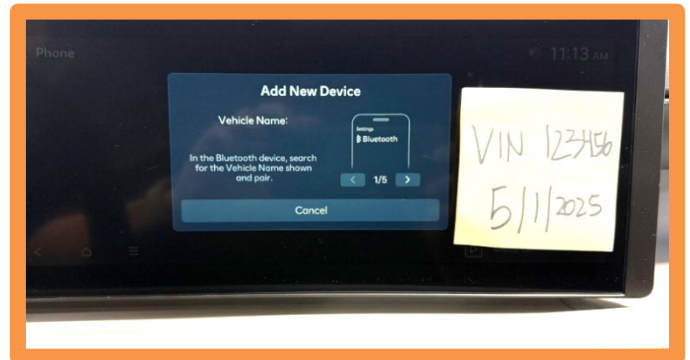
If vehicle name is missing or Bluetooth connection issues are found, please proceed with procedure.

Using STUI, take a photo of Bluetooth device/connection screen showing the missing vehicle name with the last 6 digits of the VIN and the date of repair on a piece of paper.

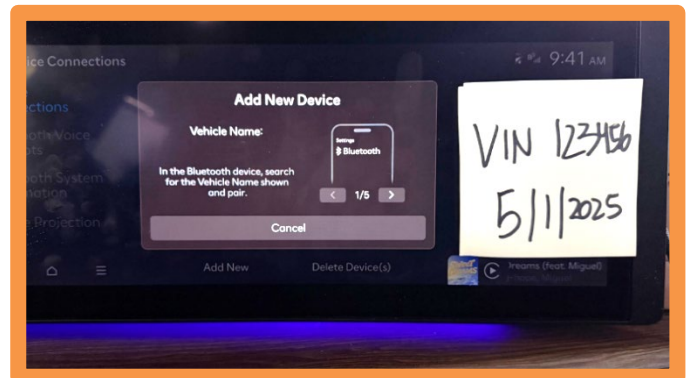
If vehicle name is missing or Bluetooth connection issues are found, please proceed with procedure.

Using STUI, take a photo of Bluetooth device/connection screen showing the missing vehicle name with the last 6 digits of the VIN and the date of repair on a piece of paper.
