Service Bulletin

Bulletin No.: 24-NA-216

Subject: BrightDrop Power Passenger Door Inoperable

Brand:	Model:	Model Year:		VIN:		Engine:	Transmission:
		from	to	from	to		
BrightDrop	Zevo 400	2024	2024				
	Zevo 600	2024	2024

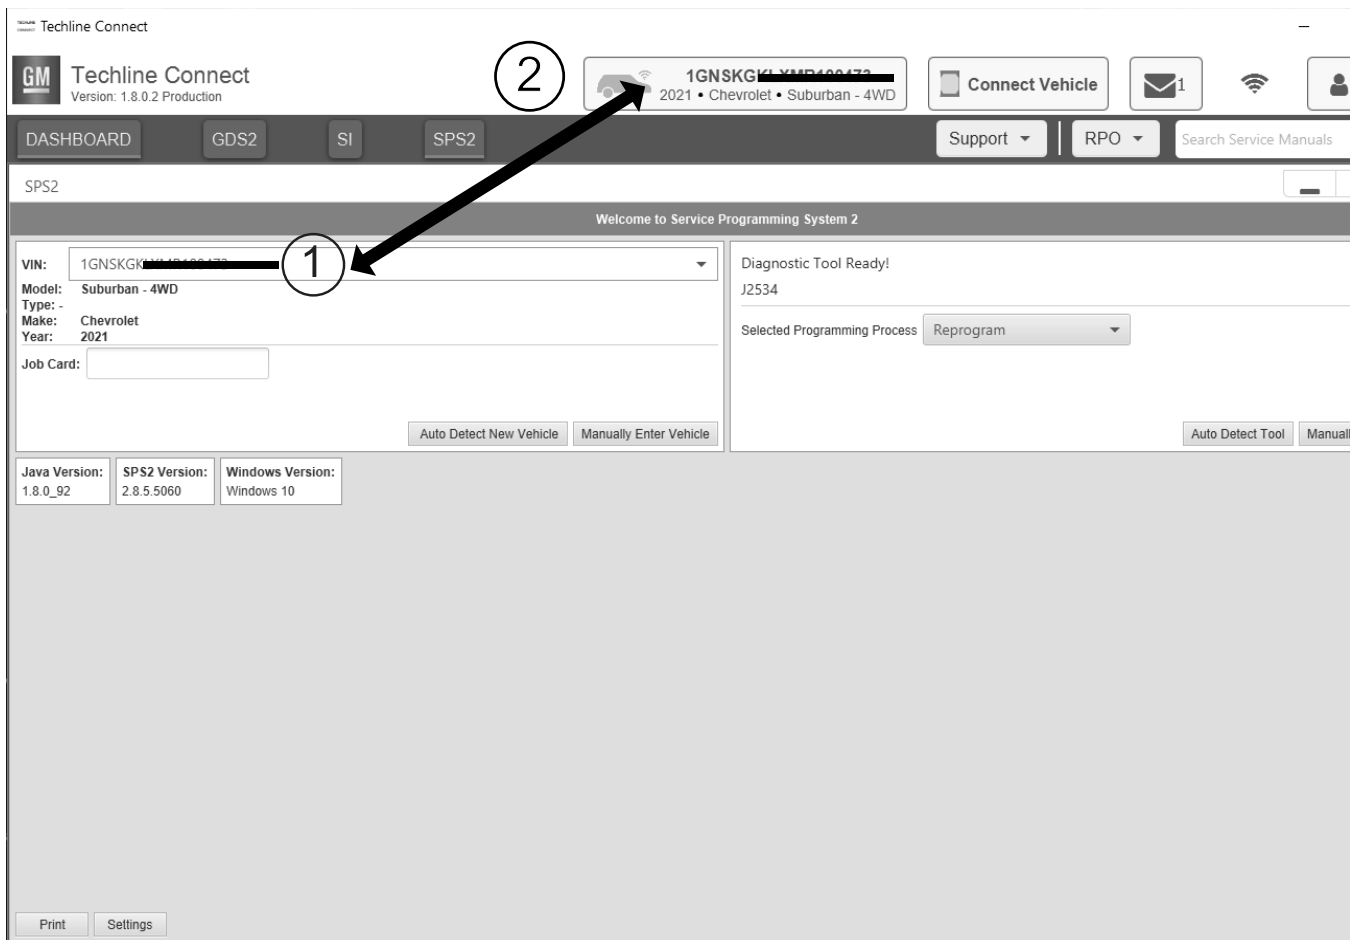
5743643

Caution: Be sure the VIN selected in the drop down menu (1) is the same as the vehicle connected (2) before beginning programming.

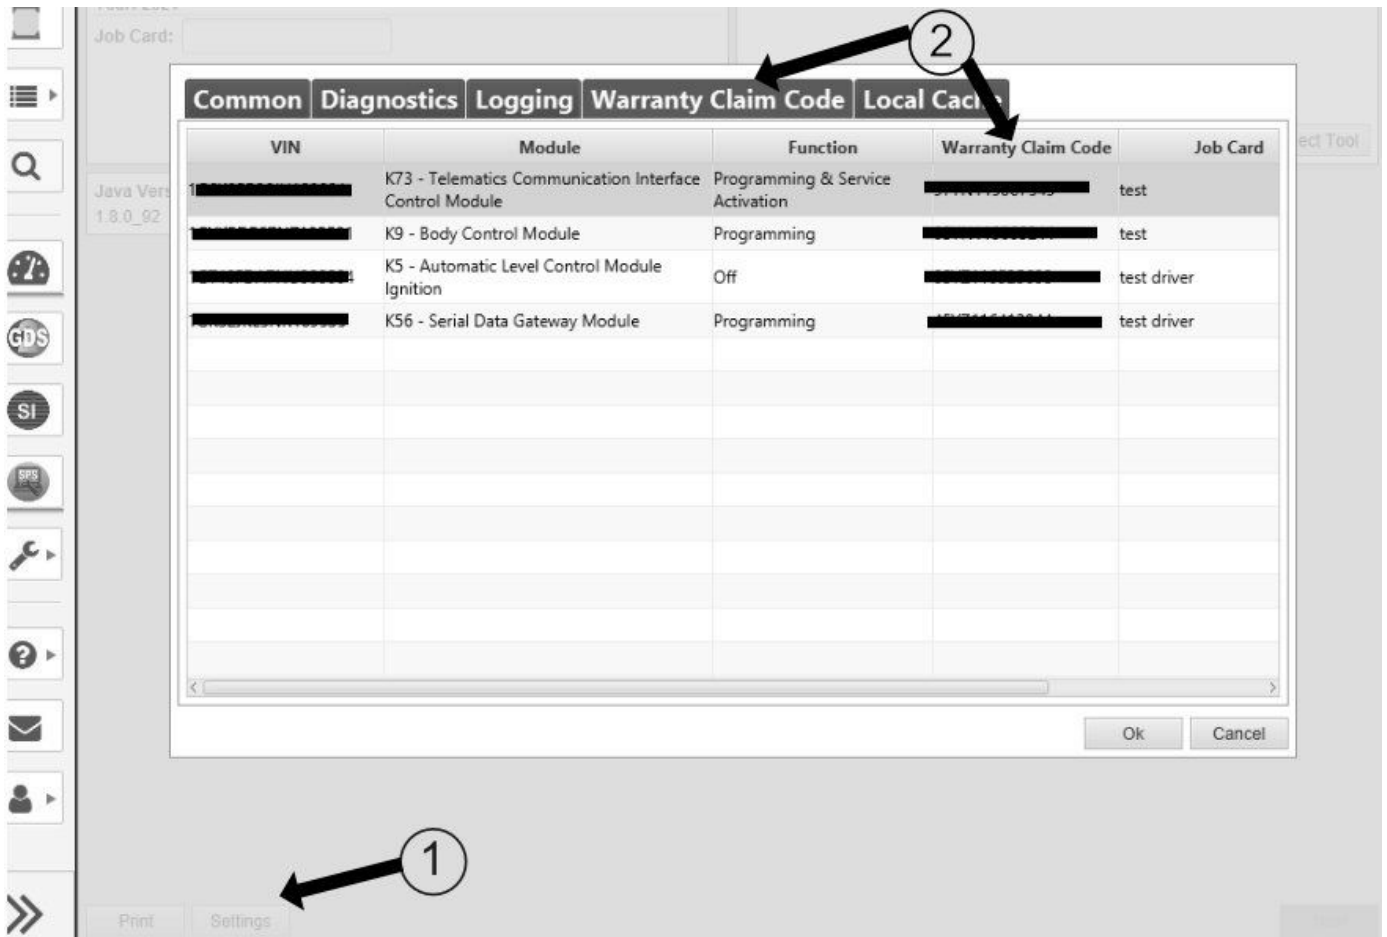
6125774

If the Warranty Claim Code was not recorded on the Job Card, the code can be retrieved in the SPS2 system as follows:

1. Open TLC on the computer used to program the vehicle.
2. Select and start SPS2.
3. Select Settings (1).
4. Select the Warranty Claim Code tab (2).

The VIN, Warranty Claim Code and Date/Time will be listed on a roster of recent programming events. If the code is retrievable, dealers should resubmit the transaction making sure to include the code in the SPS Warranty Claim Code field.
