HV DC/DC converter N83/1 BUCK mode fluctuations result in ESP warning message

Topic number	LI42.45-P-079407
Version	1
Function group	42.45 - Electronic stability program (ESP)
Date	6/12/25
Validity	243 EQB
Reason for change	adaption of font LI prep for US market

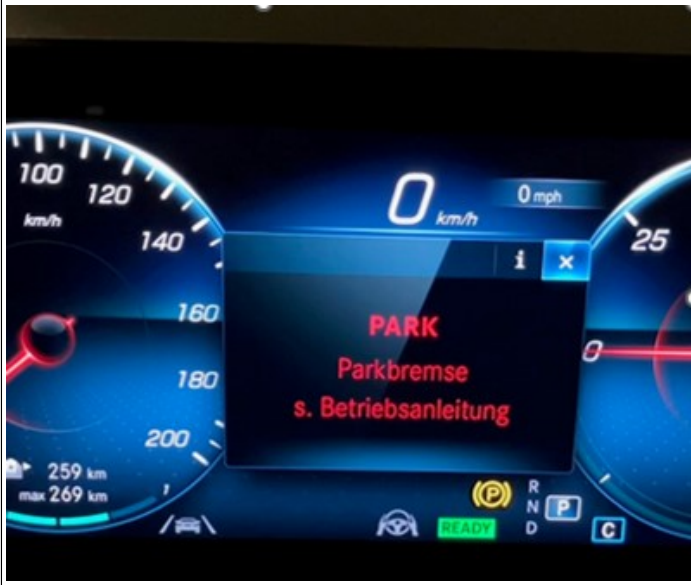
Attachments	
File	Description
DCDC KAMAYA Parkbremse Meldung KI DE.jpg	Warning message EPB, German

Instrument cluster warning lamp and/or warning message for brake system, EPB, ESP (yellow or red) and possibly 12 V battery (red)

Due to a reduction in resistance at the HV voltage divider, the DC/DC converter measures an incorrect HV voltage. Regulation of the 12 V output voltage therefore becomes unstable. I.e. the output voltage starts to fluctuate and the output current starts to jump instead of slowly regulating to the currently requested value.

The EPB position is calculated by the voltage and the current. Since these fluctuate, the ESP control unit loses its position and sets the DTCs.

- Compare the serial number of the DC/DC converter with a list of potentially affected parts in XENTRY -> DC/DC converter N83/1 -> Special Processes.
- If the evaluation comes back as defective - Replace the DC/DC converter and inspect the EPB for Subsequent complaint, defect.
- If the evaluation comes back not affected:
 - Actuate BUCK mode for approx. 30 s
 - The output current normally jumps to a high value (e.g. 100 A) and then falls slowly to the current specified value e.g. 50 A and then only changes slowly and in small increments.
 - In the event of this fault cause, the output current is subject to strong fluctuations/jumps (multiple 1-10 A) (see videos in attachment).
 - In the event of strong fluctuations and the S/N not identified in the Special Process, please open a TIPS case and attach print out of DC/DC special procedure and buck mode actual values.
