## Model Series 463 AMG: Active Distance Assist and Active Brake Assist IC Message and DTC U0416FE

Topic number	LI54.71-P-078112
Version	3
Function group	54.71 - Camera and radar-assisted assistance systems
Date	6/17/25
Validity	463 AMG
Reason for change	Updating remedy

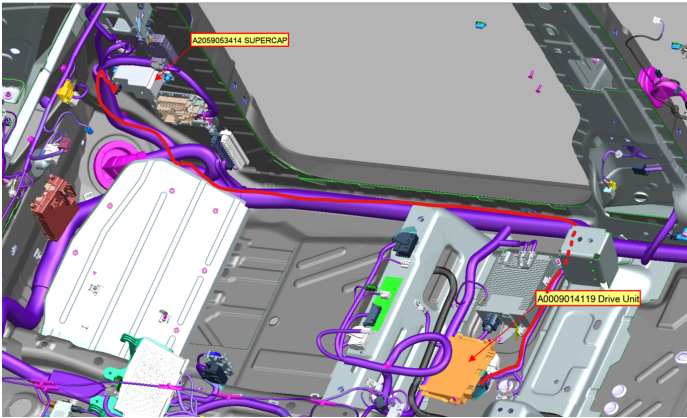
Picture 1 - Connection from Supercap to Drive Unit
<a href="#">wire+routing+Supercap+to+DriveUnit.png</a>

Missing wire between Drive Unit (N145) and Supercap (C8).

- Using a red/white cable with cross-section 0.35 mm<sup>2</sup> and overall length of approximately 2m.
- Connect Drive Unit (N145) plug A pin 18 to the 3-pin plug of the Supercap (C8) terminal 15 pin 2. Reference the new wire routing location as shown by the red line in "Picture 1 - Connection from Supercap to Drive Unit".
- The new wire should be added to the existing wiring harness as shown by the red line "Picture 1 - Connection from Supercap to Drive Unit".
- Z-Splice is the preferred method using A 000 982 91 10.
- Crimp Contact Pin (MLK) for the Drive Unit (N145) is A0485450328.
