# Insufficient Heating Output Due To Broken Refrigerant Line Between Refrigerant Compressor And The condenser (Hot Gas Line)

| Topic number | LI83.20-P-076623 |
| Validity | EQA (H243), EQB (X243) |

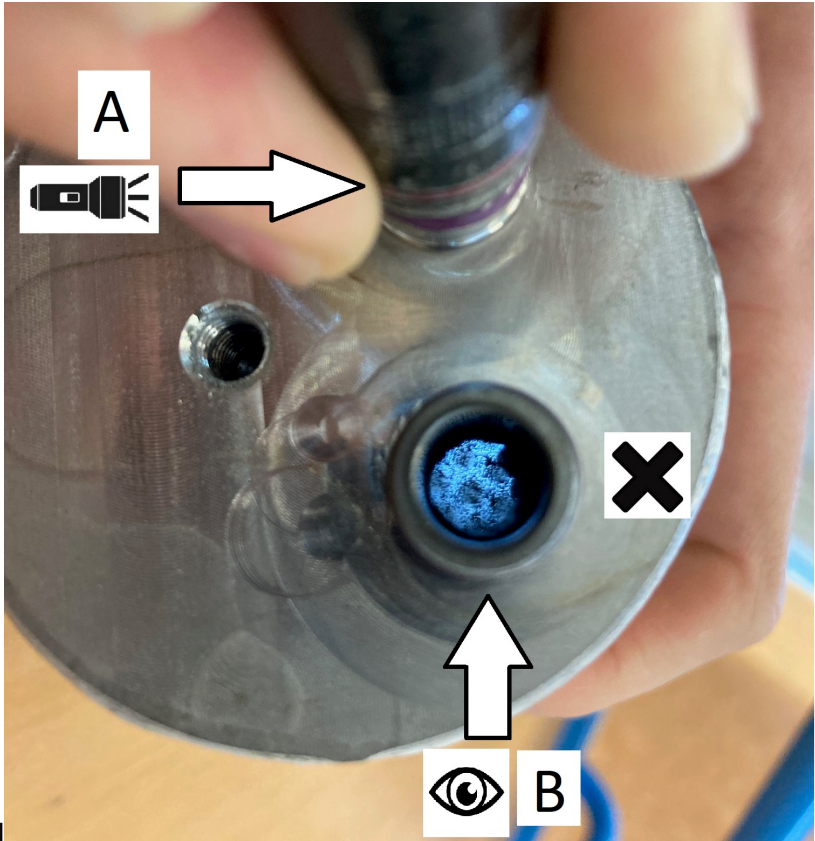
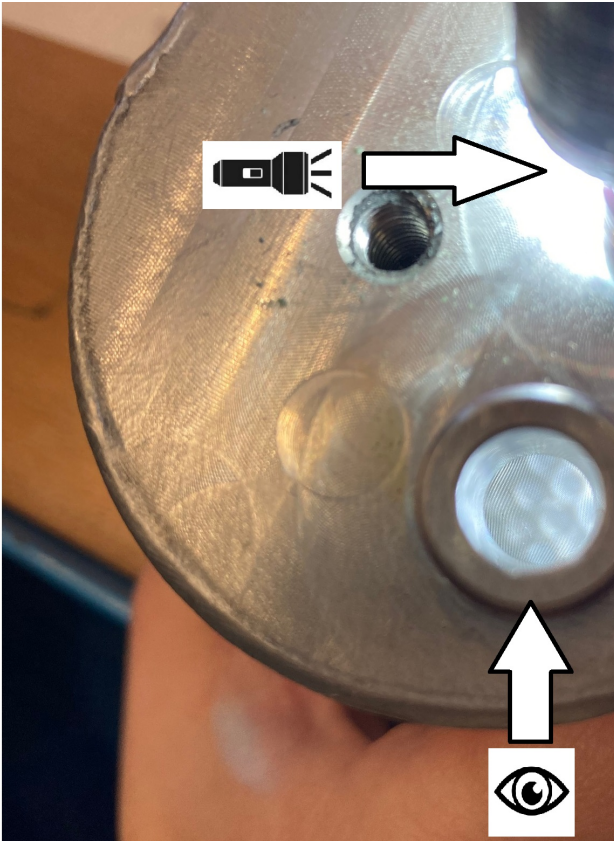
2. Check dryer cartridge at condenser for particles: Remove dryer cartridge, illuminate inlet of dryer cartridge using flashlight (A), and examine filter screen through outlet of dryer cartridge (B) -> see comparison picture bad/good
