## Entry Step Ignition Lockout

<b>Bulletin Type:</b>	TSB	<b>Publication Date:</b>	June 2025
<b>Bulletin #(s):</b>	25-012	<b>Make(s):</b>	Jayco & Entegra Coach
<b>Job Code(s):</b>	9803632	<b>Model(s):</b>	Condor (23S) Granite Ridge (23S)
<b>Flat Rate(s):</b>	9803632 1.0 HR Entry Step Ignition Repair	<b>Model Year(s):</b>	2025 - 2026

<b>Incident:</b>	Entry Step Ignition Lockout not connected.
<b>Affected Units:</b>	2025 Jayco Granite Ridge & 2025 - 2026 Entegra Coach Condor
<b>Parts Kit: 25-012JM</b>	Parts Kit #: 25-012JM
	1 - CONNECTOR,SPLICE 12-24GA 3 WIRE CLR PLSTC WAGO MFR# 221-413
	1 - FUSE,10AMP ATC/ATO-10 SPADE (Jayco Part #0052231)
	4 - TIE,CA 14.00" BLK
	1 - HOLDER,FUSE IN-LINE 24"
<b>Misc. Tools &amp; Supplies:</b>	3-Way Wagos Wire Cutters Torque Wrench with E12 Torx Socket
<b>Parts Return Information:</b>	N/A

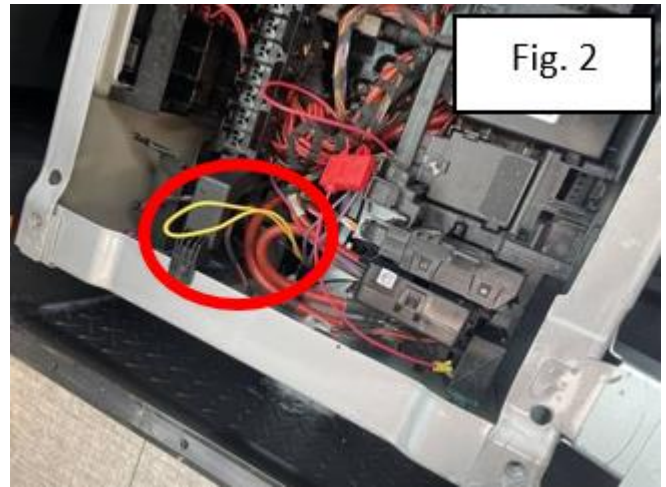
Fig. 2

2. Locate the 16AWG Yellow wire under the driver side seat base. (Figure 2)
3. Locate the red wire under the driver side seat base with the inline fuse (10A) and blue terminal ring. The wire needed, will be on the left-hand side. (Figure 3)
