## Technical Service Bulletin

<b>GROUP</b>	<b>NUMBER</b>
<b>BODY ELECTRICAL</b>	<b>25-BE-015G</b>
<b>DATE</b>	<b>MODEL(S)</b>
<b>JUNE 2025</b>	<b>GV80 (JX1)</b>

**SUBJECT:** MULTIFUNCTION SWITCH INSPECTION AND REPLACEMENT

**Description:** Some GV80 (JX1) vehicles may exhibit a rubbing/dragging noise when rotating the steering wheel due to a misaligned clock spring. Airbag operation is not affected. Follow the procedure in this TSB to inspect and, if necessary, replace the multifunction switch.

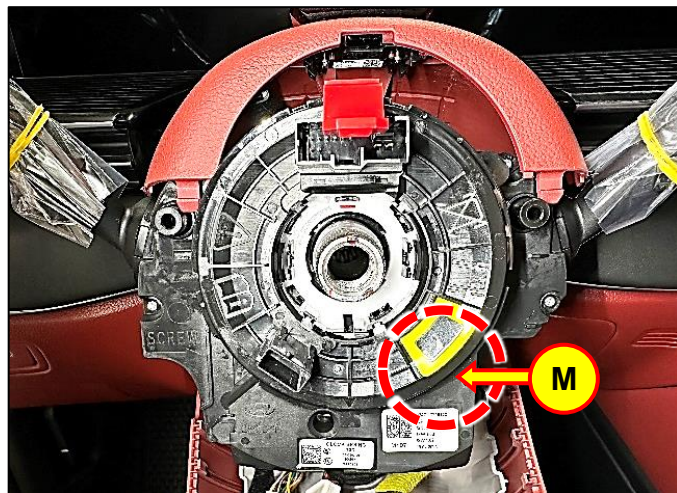
Ensure the ribbon cable (M) of the clock spring is positioned in the middle of the viewing window.

16. Insert the new clock spring and multifunction switch.

Do **NOT** remove the red clock spring locking tab as it will keep it in the correct position.
