# TECHNICAL SERVICE BULLETIN

## 400 Watt DC/AC Inverter System Inoperative With B1330:9A In The BCM

25-2273

<b>Ford</b> 2021-2025 F-150
--------------------------------

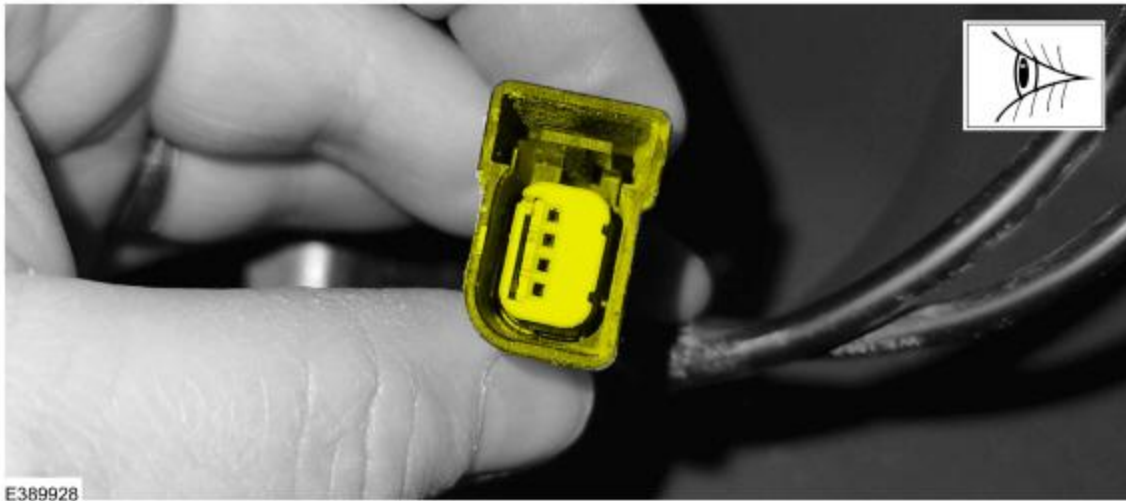
Figure 2

2. Using a suitable tool, carefully cut and remove the pickup bed AC power outlet socket harness retainer from the pickup bed AC power outlet socket harness. Discard the retainer.
3. Is the vehicle a Raptor?
  - (1). Yes - proceed to Step 4.
  - (2). No - proceed to Step 7.
4. For Raptor vehicles, inspect connector C4628 for the presence of corrosion, dirt and/or damage. Is corrosion, dirt and/or damage present in connector C4628? (Figure 2)

5. Replace the pickup bed AC power outlet socket assembly. Refer to WSM, Section 414-05. Proceed to Step 6.

(1). Yes - replace the pickup bed AC power outlet socket assembly. Refer to WSM, Section 414-05. Replace the body side harness assembly (13A409) of connector C4628. Proceed to Step 8.

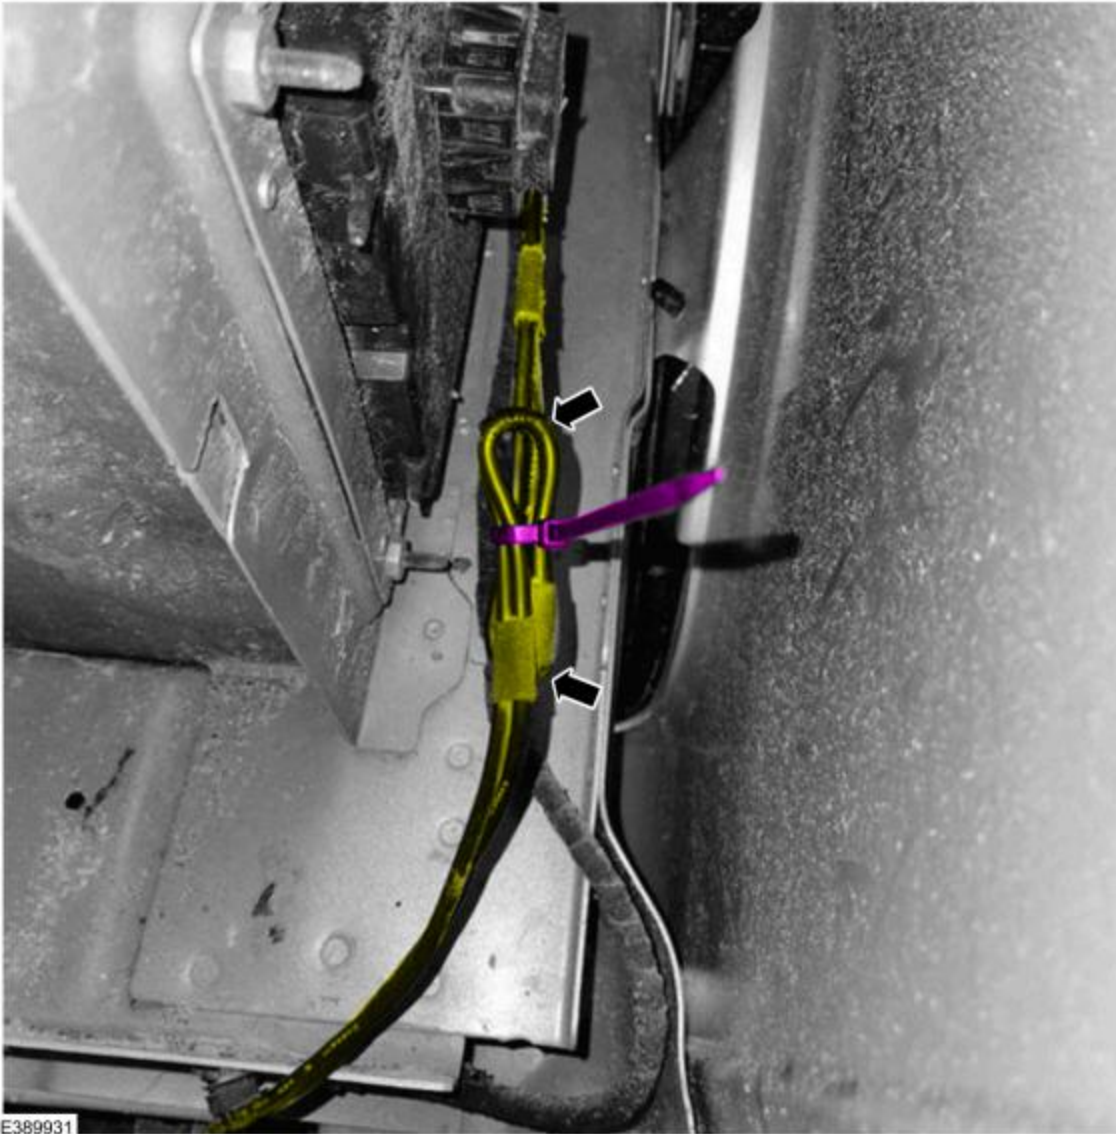
Figure 8

**CAUTION:** The bend radius of the pickup bed AC power outlet socket harness should be no less than 4 mm. Hard kinks and tight bends of the pickup bed AC power outlet socket harness can lead to wire damage.

**10.** Fold approximately 7 in. (185 mm) of the remaining/loose pickup bed AC power outlet socket harness in 2 bends just behind the pickup bed AC power outlet socket panel. Secure the folded wire with a wire tie. Inspect the routing of the harness to make sure it is not pulled too tight against the body sheet metal near the harness retainer and provides just enough length. (Figure 8)
