# Service Bulletin

Bulletin No.: 24-NA-129

**Subject: Water Leak from Around Windshield Area**

| Brand: | Model: | Model Year: | | VIN: | | Engine: | Transmission: |
|---|---|---|---|---|---|---|---|
| BrightDrop | Zevo 400 | 2024 | 2024 | - | - | All | All |

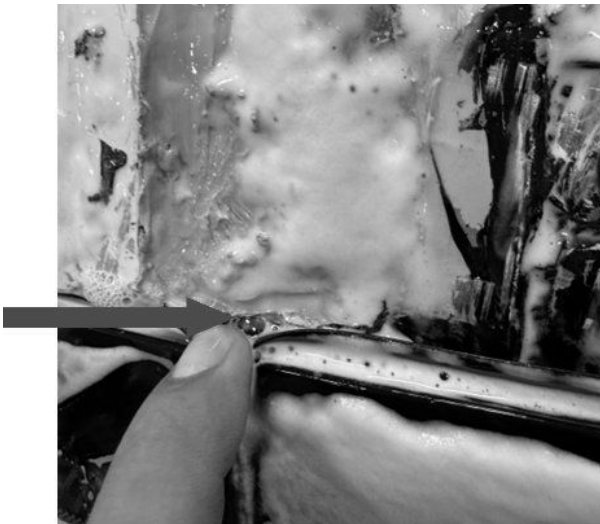
6688563

**Note:** Source of water leak found at the “rat hole” between finished roof panel and roof cap panel.

3. Air bubble test using soapy solution and air gun to confirm the rat hole is the cause of the leak.
4. Clean and prep both sides of the vehicle. Wipe aluminum surfaces with Kent Acrysol, P20005, or equivalent, to remove any residual sealer or urethane. Wipe down all aluminum surfaces with 70% Isopropyl Alcohol.

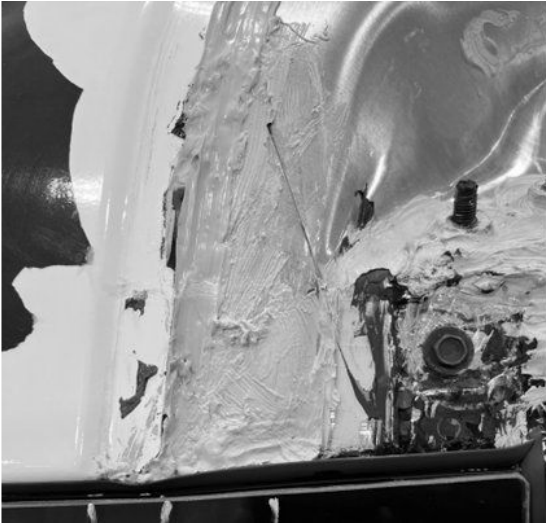
6688566

Illustration above shows un-prepped surface with old sealer present.

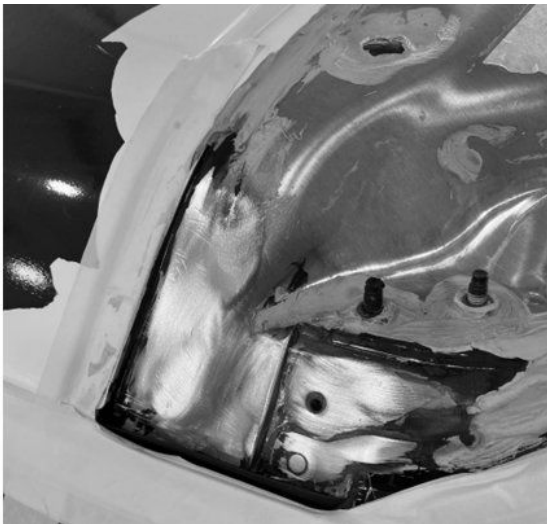
6688568

Illustration above shows prepped surface – all sealer removed.
