Service Bulletin

Bulletin No.: 25-NA-037

Subject: Diagnostic Tip on Abnormal Engine Ticking or Tapping Noise from Cam Carrier Area And Possible Misfire or Rough Run - DTC P0300 and/or P050D

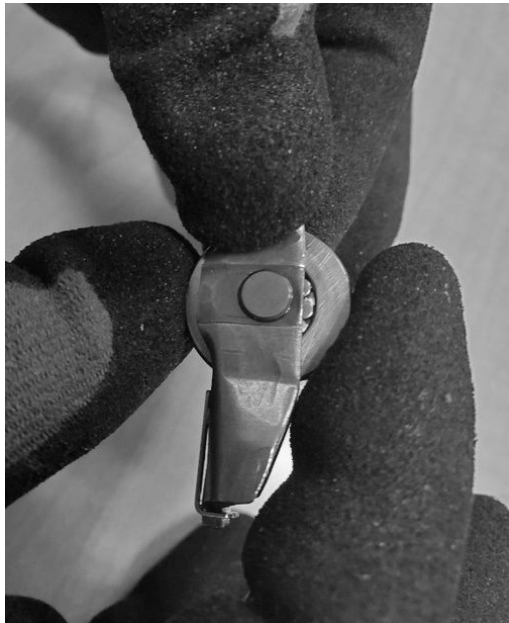
Acceptable Clearance

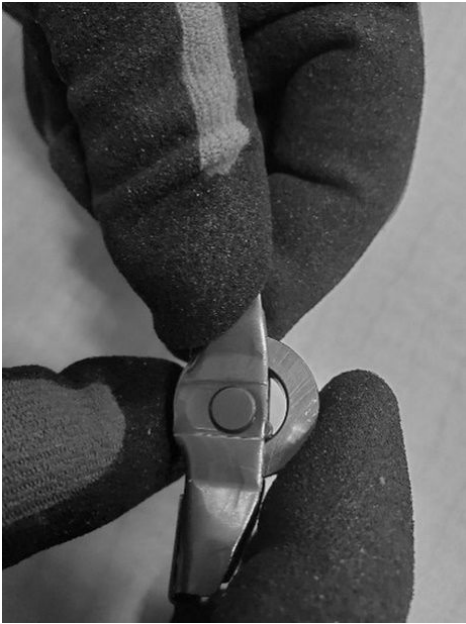
6854491

Not Acceptable Clearance

It is not typical for multiple exhaust rockers to experience this failure mode. However, if one failed exhaust rocker is found replace the entire set. It is very important to inspect each exhaust rocker in detail to determine which location is experiencing the failure. Depending on the progression of the failure mode the exhaust rocker can exhibit different amounts of clearance as shown below:

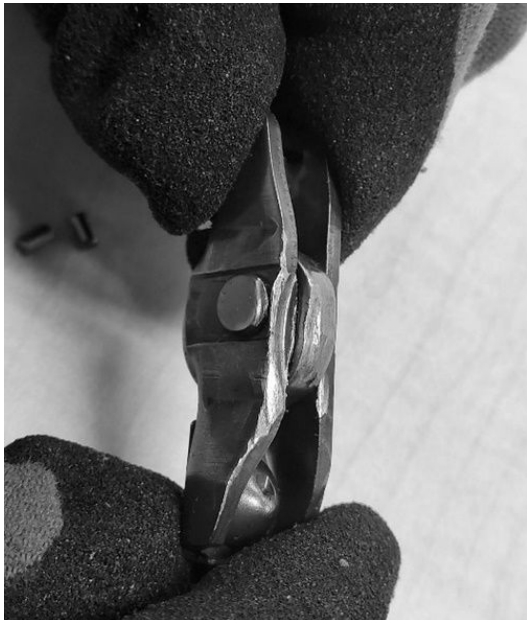
6854496

Seized Bearings

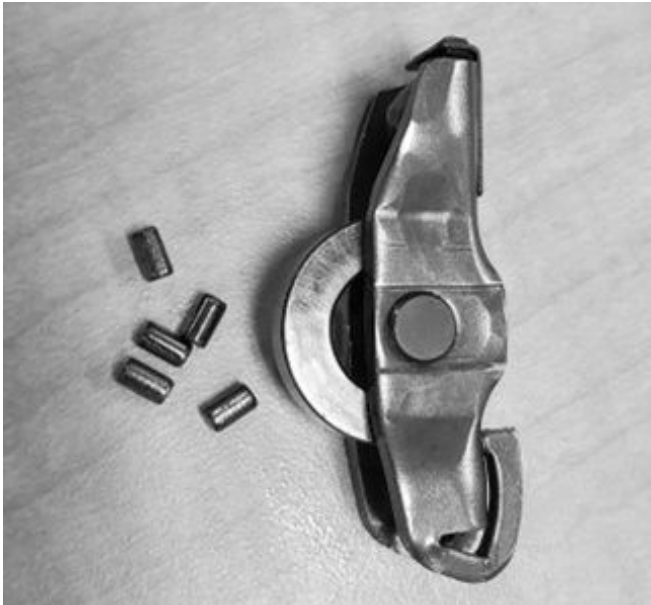
6854486

Note: Inspect the cylinder head area for any loose roller bearings and remove before reassembly. Each of the roller followers will have a total of 10 roller bearings. If loose roller bearings are found in engine oil pan reference TSB 22-NA-074 to determine if any internal engine damage has occurred.

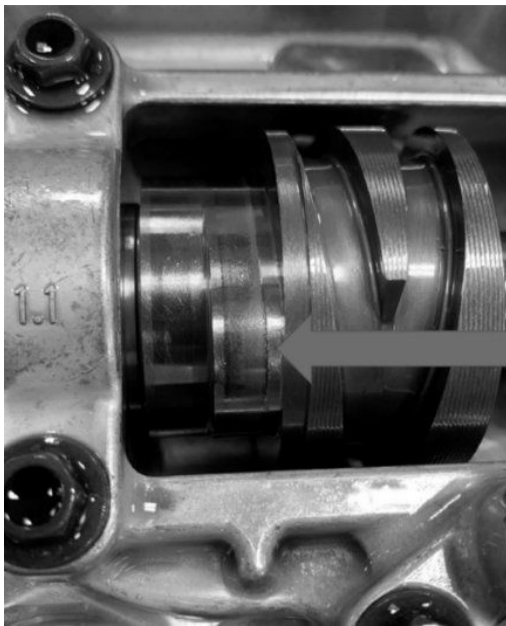
6039041

Note: The Exhaust Camshaft should be inspected at this time for damage or premature wear caused by this concern. All camshaft lobes should have similar wear patterns, if the lobe of a failed exhaust rocker shows signs of premature wear or scoring, replace the camshaft. Reference adjacent camshaft lobes without a failed exhaust rocker for example.

- (Blue arrow in picture showing Exhaust Cam lobe wear due to worn roller follower)
