Service Bulletin

Bulletin No.: 25-NA-101

Subject: Information on Airbag Light on with DTC U3000.7B and/or U3000.49 set in the Passenger Presence Module

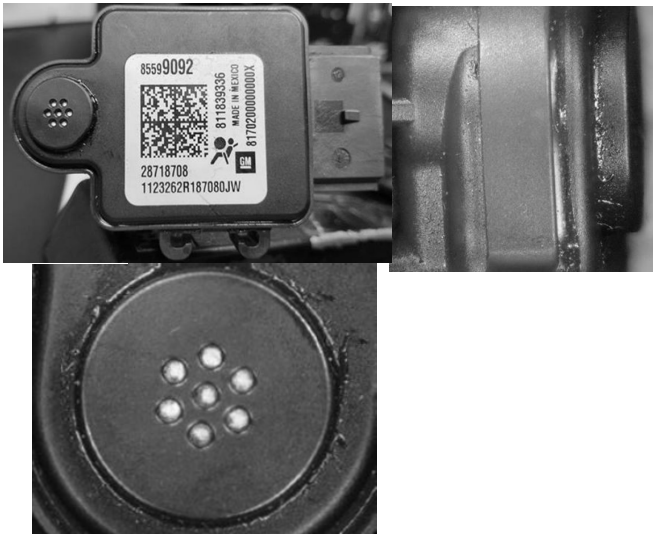
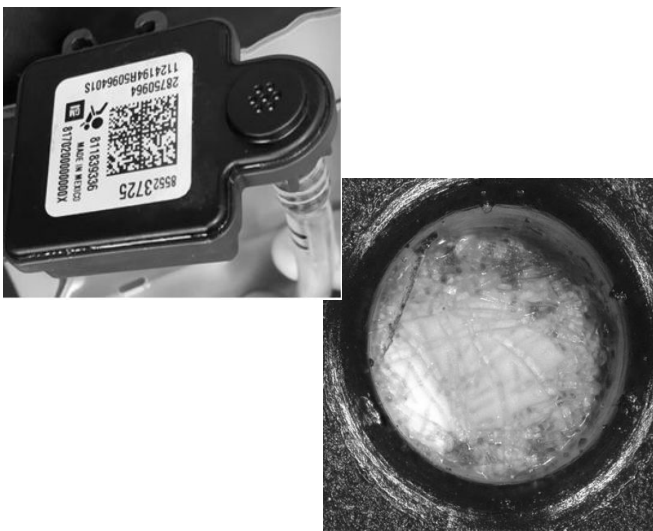
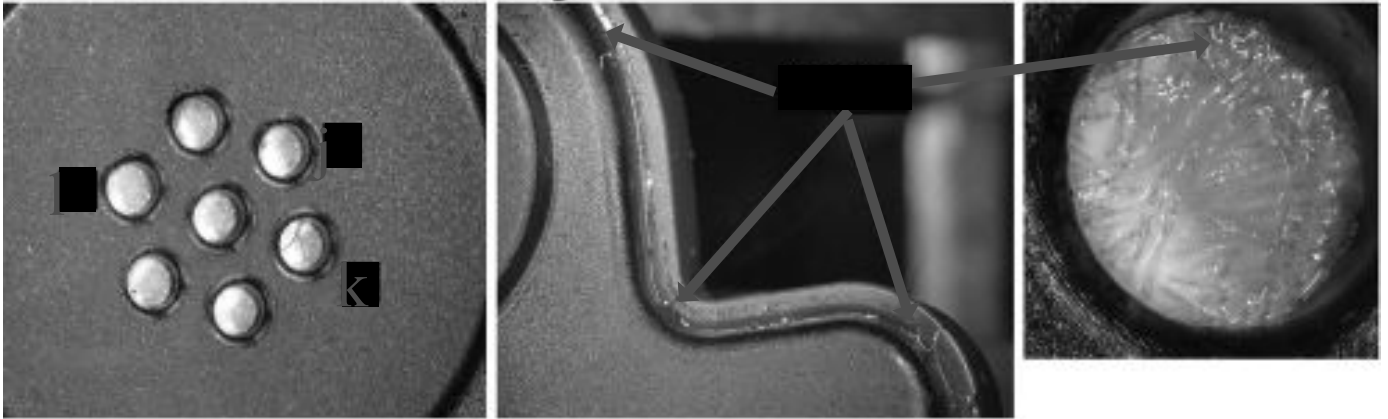
Replace the contaminated Passenger Presence Module. Contaminated pictures are shown above with clear liquid residue shown in pictures. Refer to *Airbag Front Passenger Presence Module Replacement* in SI.

Correction	Replace the contaminated passenger presence module. And use care when cleaning near the module reference port.

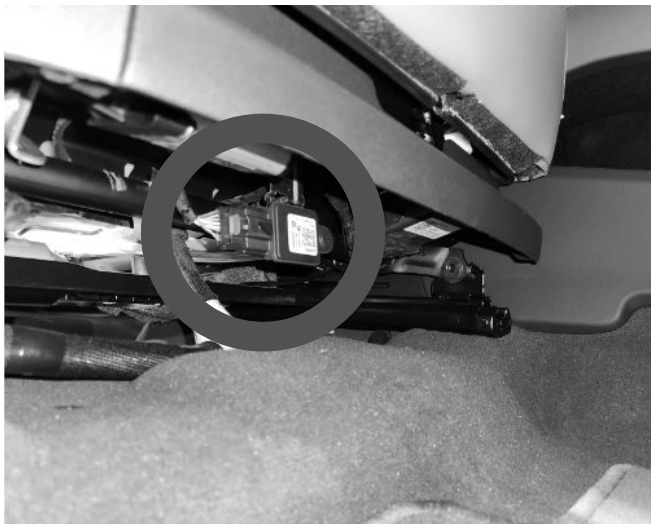
6903652

The sensor is located under the front of the passenger's seat, about 100mm from the front of the seat as seen in the picture above.

When cleaning the passenger's seat area, spray should be applied to a rag and the parts wiped as described in the owner's manual under "vehicle care".
