## STAR ONLINE PUBLICATION

**Case Number:** S2523000060

**Symptom/Vehicle Issue:** Antilock Brake System (ABS) Lamp on. Diagnostic Trouble Code(s) (DTC) C0037-2F, C003A-2F Left Or Right Rear Speed Sensor Signal Erratic Set.

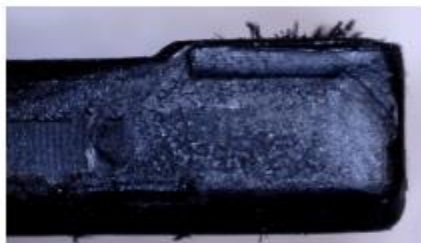
**Discussion:** Inspection of the tone wheel should be performed. Metal dust or flakes could gather around the tone wheel area causing a false signal and resulting in the DTC setting. Repair will include disassembly, inspecting the tone wheel, removing/cleaning the debris from the wheel speed sensor or the interface assembly.

Example: steel knuckle within 6mm around sensor

Metallic Debris Gathered At Wheel Speed Sensor Tip

- A. Refer to Service Library 05 - Brakes / 05 - Brakes, ABS / Electrical / RING, Tone / Removal and Installation.
- B. Clean and remove any debris including rust dust, particles sticking to the wheel speed sensor or the hub and tone wheel area. See the image below. Reassemble the vehicle.
- C. Perform a test drive. If the condition returns after a test drive, then replace the wheel speed sensor.
- D. If the condition repeats after sensor replacement, please replace the tone wheel.

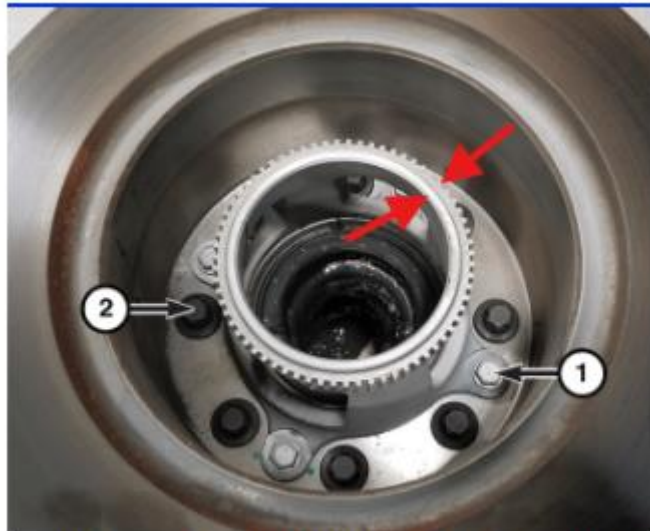
Tone wheel in-between the arrows
