STAR ONLINE PUBLICATION

Case Number: S2523000057

Symptom/Vehicle Issue: 1st Row Armrest Not Holding Position, Being Broken, Being Too Low, Or Touching The Console.

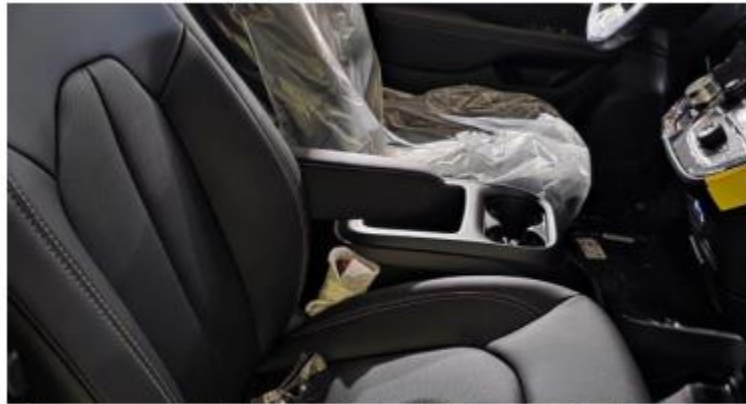
1. 1st row armrest not holding the adjustable position. 2023 and newer do not have adjustable positions. If the armrest does not hold horizontal position at its lowest design position (the armrest is not horizontal with the seat back in design position, refer to Fig 2), then follow standard inspection and repair procedure.
2. 1st row armrest being broken, DO NOT REPLACE the armrest, unless the armrest does not hold position at its lowest design position (the armrest is not horizontal with the seat in design position, refer to Fig 2).
3. 1st row armrest being too low, DO NOT REPLACE the armrest, unless the armrest does not hold position at its lowest design position (the armrest is not horizontal with the seat in design position, refer to Fig 2).

4. If the customer complaint is about the 1st row armrest touching the console, DO NOT REPLACE the armrest, unless the armrest does not hold position at its lowest design position (the armrest is not horizontal with the seat in design position, refer to Fig 2).

Fig 2: The armrest is horizontal with the seat in design position
