**Technical Service Bulletin (TSB)**  
**Front Harness Interference With Battery Support**

<b>REFERENCE:</b>	<b>TSB:</b> 08-197-25 <b>GROUP:</b> 08 - Electrical	<b>Date:</b>	June 19, 2025	<b>REVISION:</b>	—
<b>VEHICLES AFFECTED:</b>	<b>2025 - 2026 (B1) Jeep Renegade</b> This bulletin applies to vehicles built on or after November 01, 2024 (MDH 1101XX) and on or before April 26, 2025 (MDH 0426XX) equipped with 1.8L I4 E-Torque Engine (Sales Code EBD).			<b>MARKET APPLICABILITY:</b> <input type="checkbox"/> NA <input type="checkbox"/> MEA <input checked="" type="checkbox"/> SA <input type="checkbox"/> IAP <input type="checkbox"/> EE <input type="checkbox"/> CH <b>NOTE:</b> This bulletin applies to South America markets.	
<b>CUSTOMER SYMPTOM:</b>	<b>Customers may comment on one or more of the following:</b> <ul style="list-style-type: none"> <li>Warning light on Instrument Panel Cluster (IPC), with warnings of electric fan faults.</li> <li>Smoke smell.</li> </ul>				
<b>CAUSE:</b>	Contact between the wiring harness and the vehicle battery holder

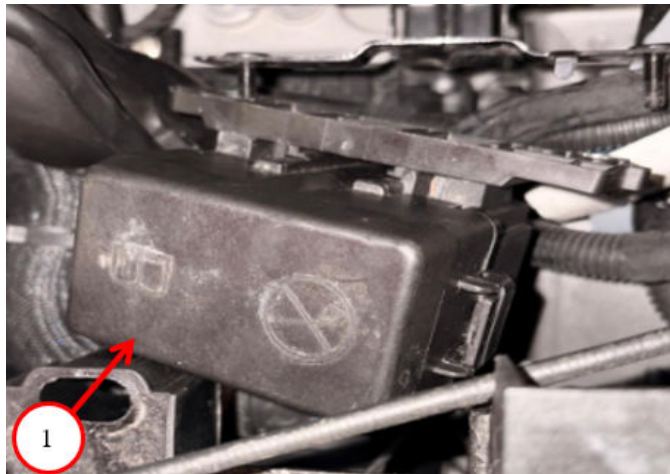
**Fig. 3**  
Remove Fuse Box

4. Inspect for wire harness interference with the battery holder.
5. Is there interference from the wire harness with the battery holder?
  - YES>>> Proceed to [Step 6](#).
  - NO>>> Proceed to [Step 7](#).
6. Repair the damaged wire harness. Refer to the detailed service procedures available in DealerCONNECT/ Service Library under: “Service Info > Informações sobre serviço> Procedimentos Padrão – NI - Reparo de Chicote- Emenda Utilizando Luvas Termorrestringentes” and then proceed to [Step 7](#).

3. Remove the fuse box (module 2A5) to gain access to the bracket plate [Fig. 3](#).

1 - Fuse Box
